Illawarra Escarpment Mountain Bike Concept Plan Geotechnical Assessment Report (Revised Trail Network)

Niche Environment and Heritage Pty Ltd

24 March 2022

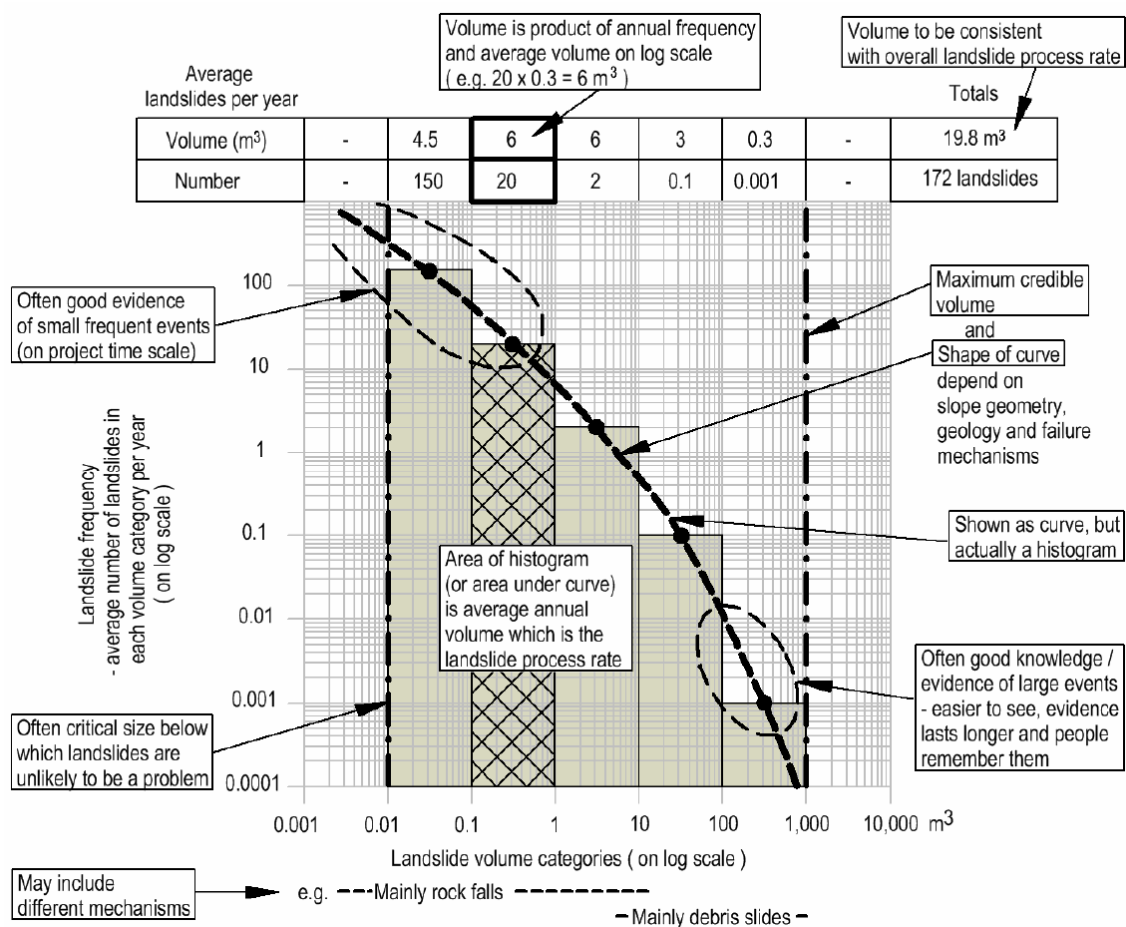
Figure 12: Explanation of the graphical presentation of a Landslide Volume Frequency Model (Moon et al. (2005))

For the purpose of this project, we have developed a landslide volume frequency model (Figure 12) which predicts the long-term average number and volume of rockfalls detaching from the upper escarpment cliff-lines each year. Given that the geology and geomorphic conditions at each geohazard risk site are similar, and there is no specific rockfall frequency data available, we have developed one general model to represent landslide processes. Using knowledge about rockfall reach probability, the model can be used to estimate the likelihood of rockfall debris reaching the mountain bike trails. The approach to developing and using landslide volume frequency models is given in Moon et al. (2005). Figure 12 provides an example of interpreting landslide volume frequency models.
