# Illawarra Escarpment Mountain Bike Concept Plan Geotechnical Assessment Report (Revised Trail Network)

Niche Environment and Heritage Pty Ltd

24 March 2022

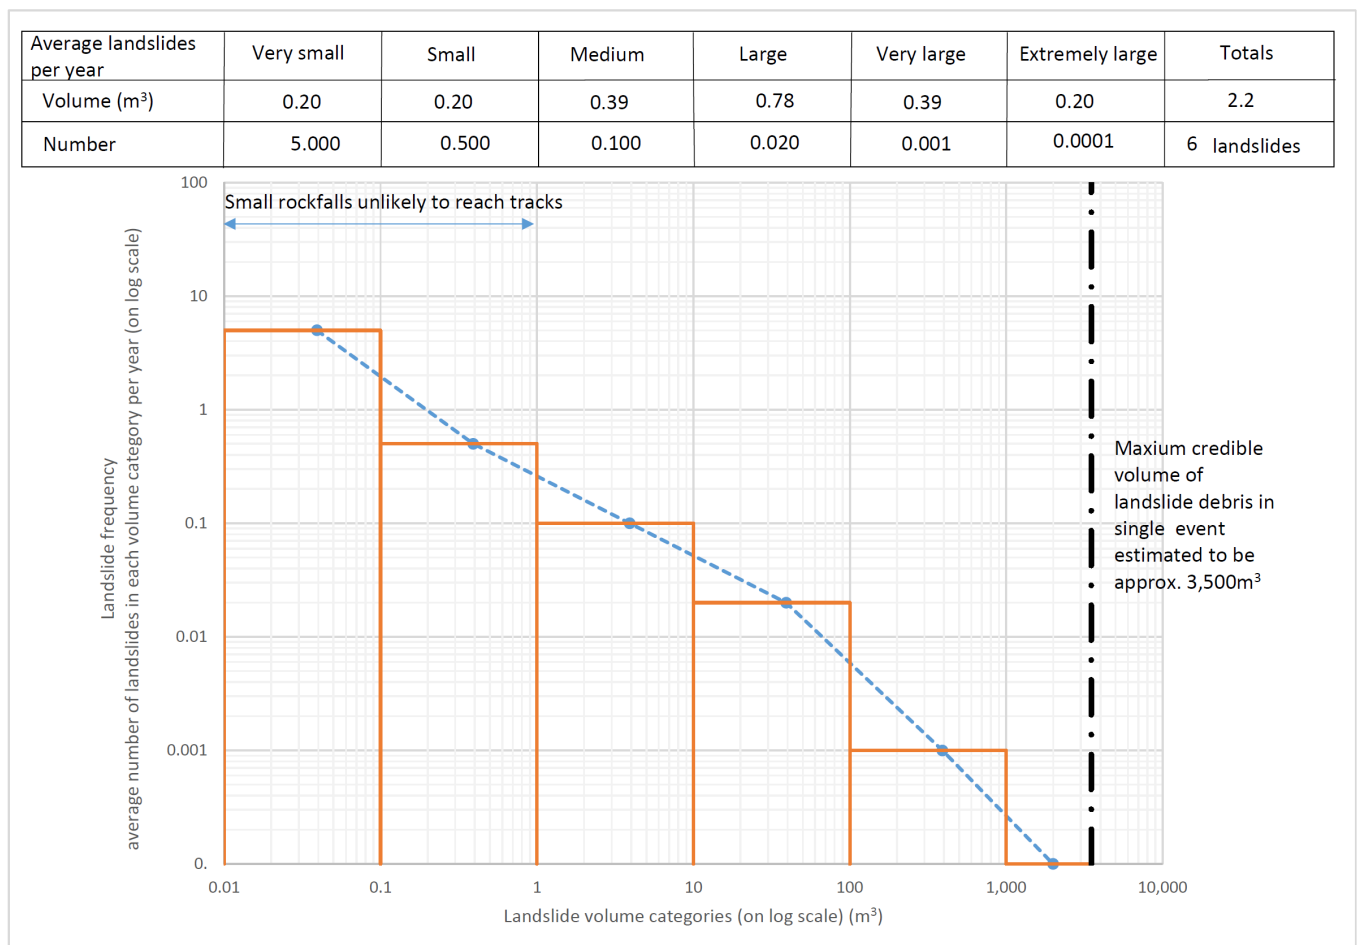
Figure 13: Landslide volume frequency model for Upper Cliff-Lines normalised for each 100 m escarpment

- 'Large' sized rockfalls (i.e. volumes of 10 m<sup>3</sup> to 100 m<sup>3</sup>) could be expected to occur about every 50 years
- 'Very large' sized rockfalls (i.e. volumes of 100 m<sup>3</sup> to 1000 m<sup>3</sup>) could be expected to occur about every 1,000 years

The landslide model is presented in Figure 13. The model has been normalized to show the size and frequency of landslide debris detaching from a 100 m length of the escarpment cliff-line.

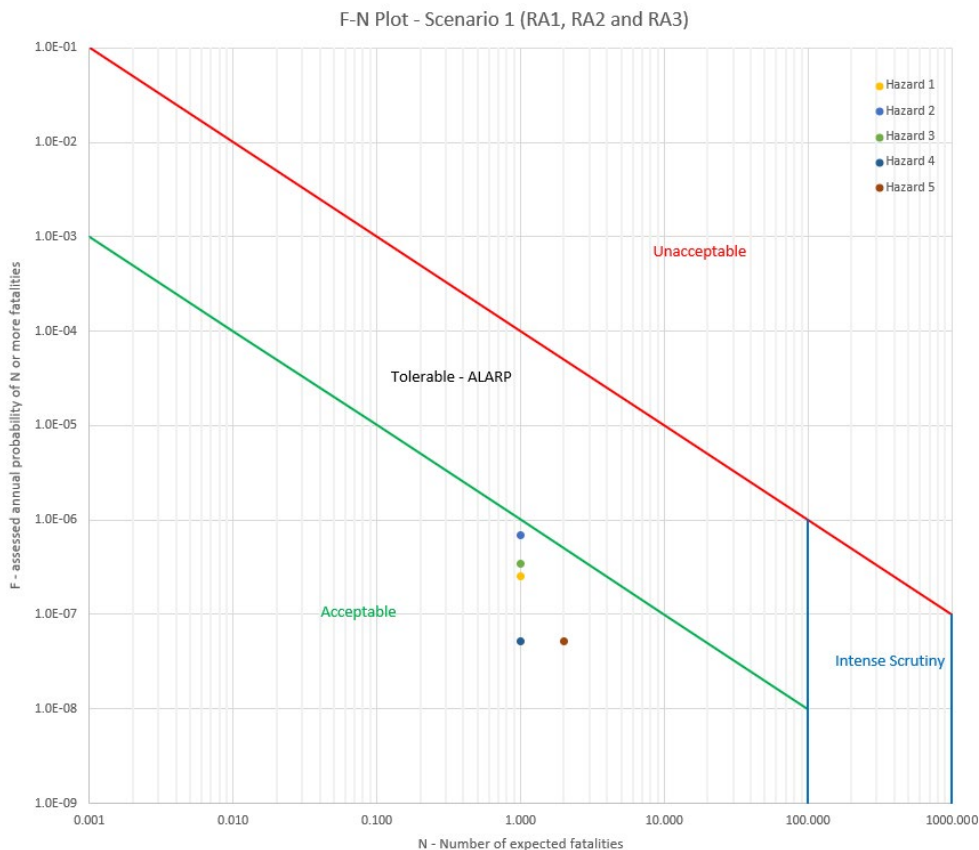
Figure 14: F-N plot for Scenario 1 (RA1, RA2 and RA3), including societal risk thresholds for new developments

As illustrated in the F-N plots, the assessed risks for Hazards 1 to 5 in both Scenarios 1 and 2 fall within the "acceptable risk" category, as defined by NPWS (2020).

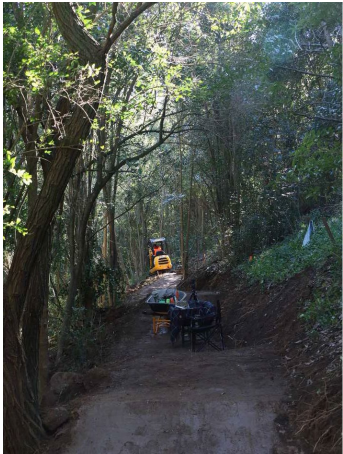
<p>Trail corridor clearing, flagged line by builder approved on site by landowner before cut vegetation. Vegetation used to shut down illegal trail nearby. Before &amp; after photo. After photo indicated full bench cut with 1m high cut back</p>	<p><b>Blue</b>, Black</p>	<p><b>General comment:</b> Soil material placed at the edge of the trail on the downslope side may be susceptible to erosion. Limit extent of clearing to areas ready for trail construction</p> <p><b>Construction:</b> Recommend some form of protection to the upslope cut batters</p> <p><b>Maintenance:</b> Regular inspection and hand tool corrective works, and maintenance of drainage.</p>
