Public Works  
Advisory

# Development of Methodology and Visual Audit for Urban Levees

Report Number: ISR20177

December 2020

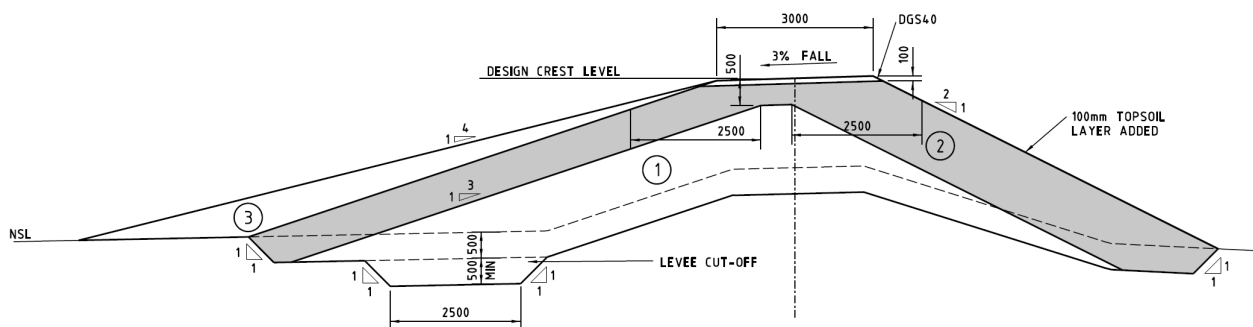
**Figure 10-1 Typical Keyway (cut-off) under a Levee Embankment**

- “Key” in the artificial levee embankment into the natural ground to minimise lateral movements.
- Block uncontrolled seepage through pervious foundation strata between the impervious part of the embankment and the impervious soil foundation. It usually consists of an excavated trench, backfilled with compacted clay as part of the embankment core. An example of a keyway is shown in Figure 10-1.

The design of a levee needs to be checked for the presence of a keyway.

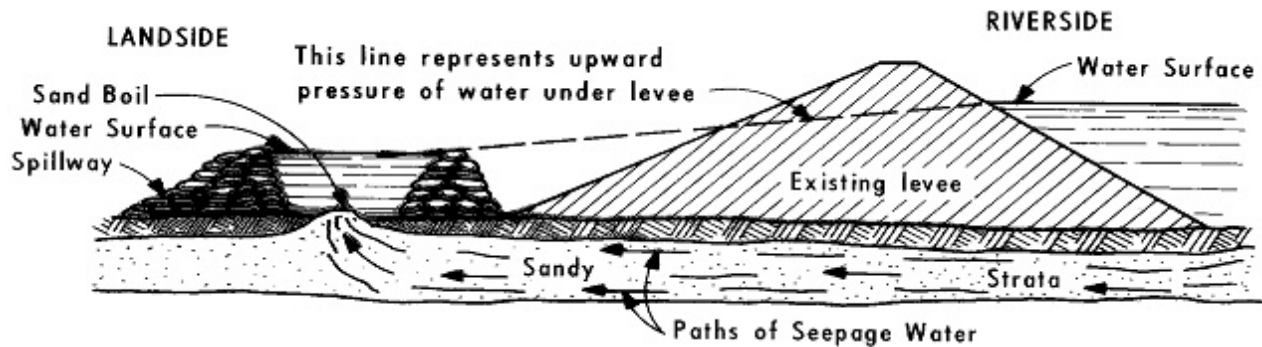
**Figure 10-2 Uncontrolled Seepage under a Levee Embankment**

An example of what could happen if no keyway is in place, i.e. foundation piping, development of town side soil boils as a result of efficient foundation seepage paths, is shown in Figure 10-2.

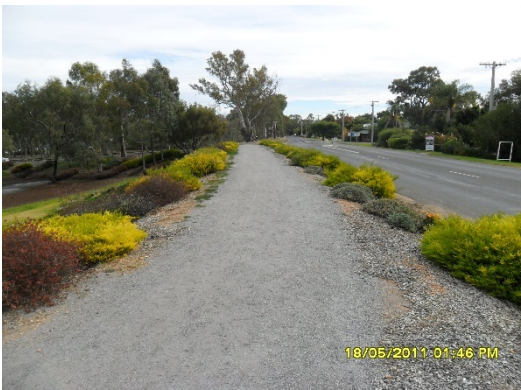
<b>2.0 Earth Levee – Crest</b>							
<b>2.1 Levee crest level below design crest level (i.e. surface erosion of crest due to local rain)</b>							
✓	<p><b>Acceptable</b></p> <p>Levee crest level at or above design crest level.</p>

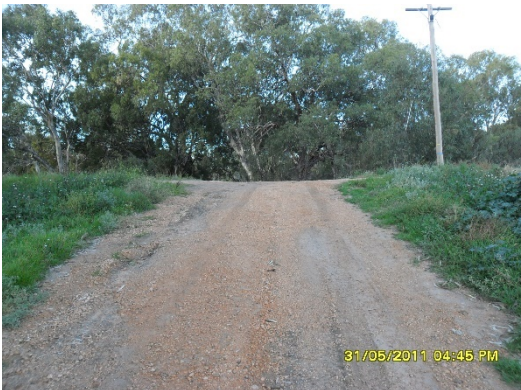
-	-	-	-	-
±	<p><b>Marginal</b></p> <p>Levee crest level below design crest level by &lt; 150mm.</p> <p>Commonly occurs at vehicle and stock crossings.</p>

Minimal	The levee may not provide full protection in the design flood due to loss of freeboard.	Determine appropriate freeboard allowance if not known.	<p>Place and compact more gravel on top or more suitable clay material.</p> <p>Add this or equivalent in sandbagging to operational requirement if it can be addressed in the effective warning time available.</p> <p>Schedule for rectification within 6 months if warning time enables placement of material in lead time for flood.</p> <p>If little warning time schedule rectification within a shorter timeframe</p>	<p>Monitor annually if not used for vehicular crossing. If used for vehicular crossing monitor every 3 to 6 months.</p> <p>Level of protection lowered by amount levee crest below design crest level unless contingency plans can be readily enacted within the available warning time.</p>

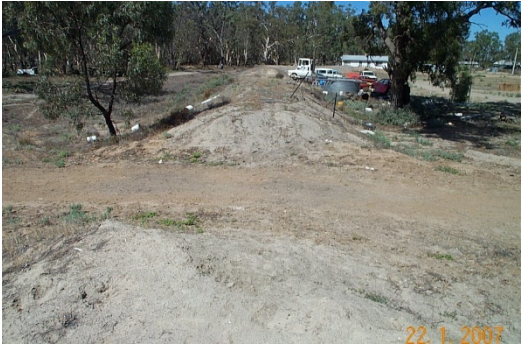
Description of Potential Risk and Assessment of Severity of Risk Issue		Potential Consequences		Details of any further investigations required	Possible rectification and prioritisation	Monitoring Program (if marginal risk only)	Assessment of Reliability of levee with Current Risks	
		Short Term	Long Term					
✘	<p><b>Unacceptable</b></p> <p>Levee crest level below design crest level by &gt; 150mm.</p> <p>Can occur at poorly maintained vehicle or stock crossings</p>

<p>May compromise maintenance access</p>	<p>In a major flood the design flood level will be compromised.</p> <p>Structural failure of the levee is possible</p>	<p>Determine appropriate freeboard if not known.</p> <p>Check stability/integrity of levee section.</p>	<p>Place and compact additional, suitable clay material plus 100-150mm gravel top.</p> <p>Add this or equivalent in sandbagging to operational requirement if it can be addressed in the effective warning time available.</p> <p>Schedule for rectification within 1 month.</p>	<p>Monitor every 3 to 6 months after rectification</p>	<p>Level of protection lowered by amount levee crest below design crest level unless contingency plans can be readily enacted within the available warning time.</p>

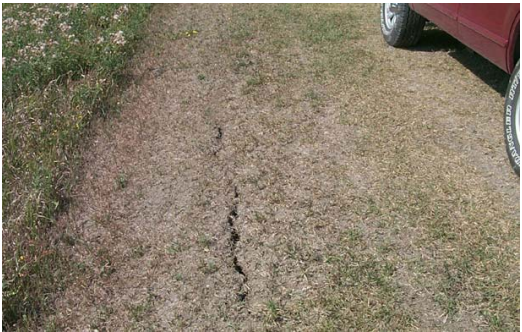
<b>2.2 Surface cracking – Longitudinal</b>								
✔	<p><b>Acceptable</b></p> <p>Cracks in the crest &lt;150mm deep (middle of levee).</p>

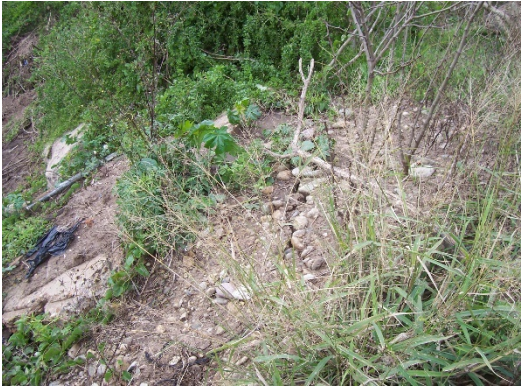
-	-	-	-	<p>Monitor crack depths and widths annually and during flood events</p>	<p>In event of a flood before rectified, check for any deterioration in condition</p>
±	<p><b>Marginal</b></p> <p>Cracks in the crest &lt;150mm deep adjacent to levee batters.</p>

<p>Nil</p>	<p>Allow minor amounts of rainwater to pond and seep into the levee but limited impact on levee stability.</p>		<p>To be repaired as moderate priority in Maintenance Program.</p>	<p>Monitor every 6 months and during flood event.</p>	<p>In event of a flood before rectified, monitor regularly to assess whether cracks are becoming unacceptable</p>
✘	<p><b>Unacceptable</b></p> <p>Cracks greater than 150mm deep that will pond water.</p>

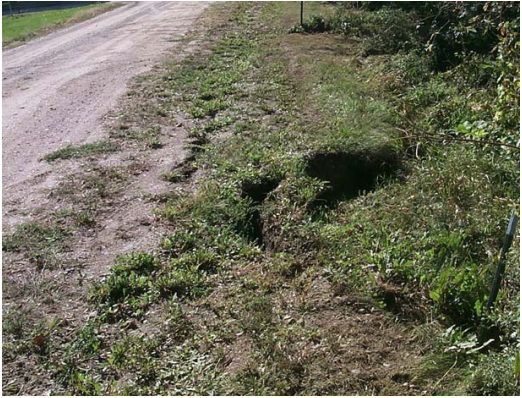
<p>Allow significant amount of rainwater to pond and seep into the levee.</p>	<p>Allow significant amount of rainwater to pond and seep into the levee.</p> <p>Weaken the levee and lessen the level of protection and / or effectiveness of freeboard.</p>	<p>Levee audit required ASAP</p>	<p>Cracking to be remediated as a high priority in Maintenance Program</p>	<p>Monitor every 6 months and during flood event after rectification.</p>	<p>Moderate to high risk of failure depending on degree of penetration into levee structure.</p>

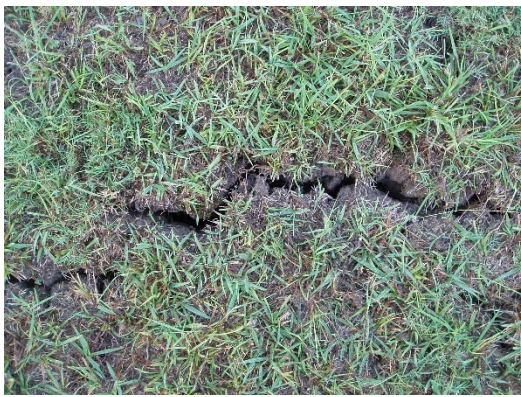
Description of Potential Risk and Assessment of Severity of Risk Issue		Potential Consequences		Details of any further investigations required	Possible rectification and prioritisation	Monitoring Program (if marginal risk only)	Assessment of Reliability of levee with Current Risks
		Short Term	Long Term				
<b>2.3 Surface cracking – Transverse</b>							
✓	<p><b>Acceptable</b></p> <p>Cracks in the crest &lt;150mm deep (from middle - town side only).</p>	Insert Photo	-	-	-	-	Monitor crack width and depth for deterioration annually-
±	<p><b>Marginal</b></p> <p>Cracks in the crest &lt;150mm deep (water side) that would not pond water.</p>

Nil	Allow minor amount of rainwater to pond and seep into the levee.	-	To be repaired as moderate priority in Maintenance Program.	Monitor crack width and depth for deterioration annually and during flood events. Risk of failure limited to moderate providing no other defects compound the issue.

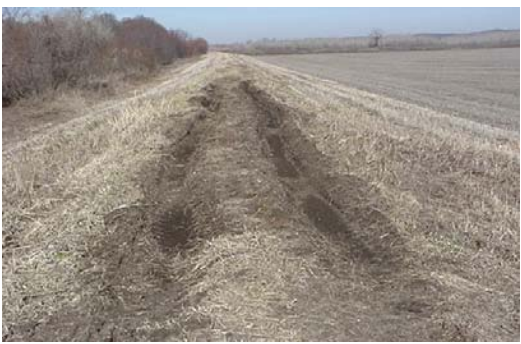
Description of Potential Risk and Assessment of Severity of Risk Issue			Potential Consequences		Details of any further investigations required	Possible rectification and prioritisation	Monitoring Program (if marginal risk only)	Assessment of Reliability of levee with Current Risks
			Short Term	Long Term				
±	<p><b>Marginal</b></p> <p>Infrequent ruts, depressions or holes less than 100mm deep in crest that will pond water.</p>	 	Nil	Allow rainwater to pond, seep into the levee.	-	Place and compact more gravel on crest of levee as a medium priority in the maintenance plan	Monitor every 6 months	<p>Minimal risk of breach depending on design freeboard.</p> <p>If public have access need to consider trip hazard and associated public liability.</p>
✘	<p><b>Unacceptable</b></p> <p>Depressions greater than 100mm that will pond water.</p>

Allow significant amount of rainwater to pond and seep into the levee.	<p>Allow significant amount of rainwater to pond and seep into the levee.</p> <p>Weaken the levee and lessen the level of protection and / or effectiveness of freeboard.</p>	Determine depth of depression and investigate the structural integrity of the subgrade (material below topsoil/gravel) to determine deterioration.	Remediate depressions ASAP. This may involve replacing subgrade where it is unsuitable with more suitable clay material and placing and compacting more gravel on levee crest.	Monitor every 6 months after rectification	<p>Level of protection lowered by depth of depression if within 1m of waterside batter.</p> <p>If public have access need to consider trip hazard and associated public liability.</p>

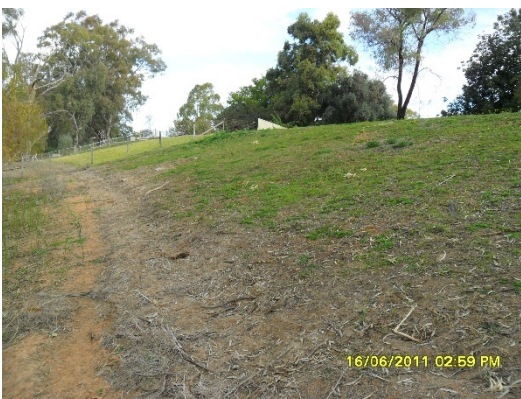
<b>3.0 Earthen Levee – Batters</b>								
<b>3.1 Surface erosion of batters due to local rain</b>								
✓	<p><b>Acceptable</b></p> <p>Minor scouring less than 50% design depth of the topsoil leaving sufficient topsoil for groundcover to grow and stabilise batter.</p>

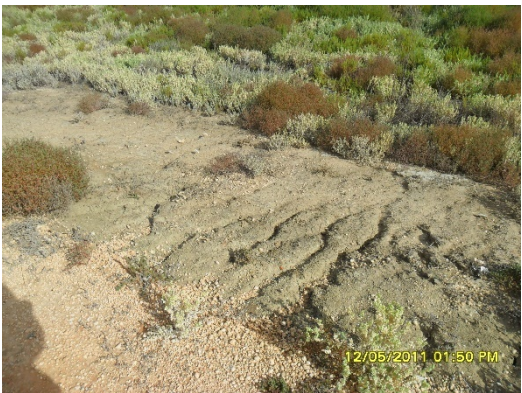
Description of Potential Risk and Assessment of Severity of Risk Issue			Potential Consequences		Details of any further investigations required	Possible rectification and prioritisation	Monitoring Program (if marginal risk only)	Assessment of Reliability of levee with Current Risks
			Short Term	Long Term				
±	<p><b>Marginal</b></p> <p>Scouring greater than 50% of the design topsoil.</p>

Nil	<p>Insufficient topsoil left for groundcover to grow and stabilise embankment leading to further erosion.</p>	-	<p>Reinstate topsoil to original design depth. Seed and / or mulch batters or place strips of turf where appropriate conditions exist.</p>	<p>Monitor annually and after a flood event</p>	<p>Low to moderate risk of structural failure of levee.</p>
✘	<p><b>Unacceptable</b></p> <p>Scouring that has removed all the topsoil and penetrated into the levee structure itself.</p>

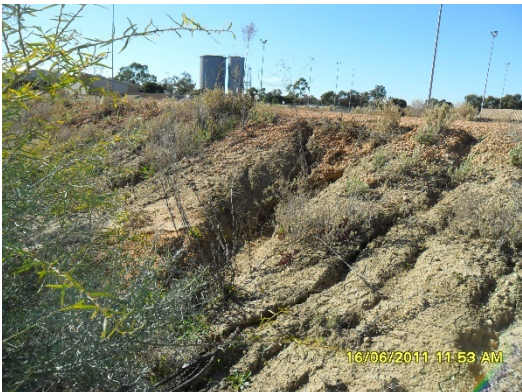
<p>Insufficient topsoil left for groundcover to grow and stabilise embankment leading to further erosion.</p>	<p>Major erosion into levee structure has already occurred. Major maintenance required to avoid structural failure.</p>	<p>Refer to original construction specification for remediation guidelines.</p>	<p>Immediately repair structural defects in levee batters. Reinstate topsoil to original design depth. Seed and / or mulch batters or place strips of turf where appropriate conditions exist.</p> <p>Rectify concentration of rainfall runoff from levee crest.</p> <p>URGENT</p>	<p>Monitor annually and after a flood event once rectified</p>	<p>High risk of structural failure of levee</p>

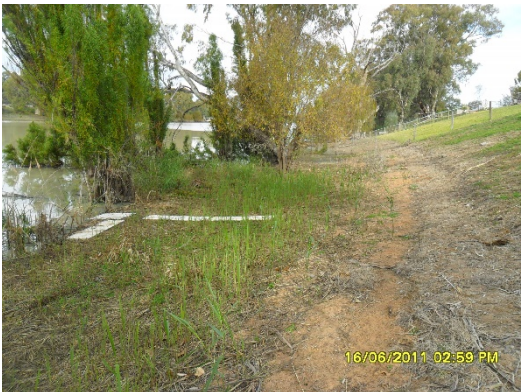
3.2	<b>Erosion of batters due to water flows</b>							
✓	<p><b>Acceptable</b></p> <p>Minimal erosion not undercutting the river side batter of the Levee Bank.</p>

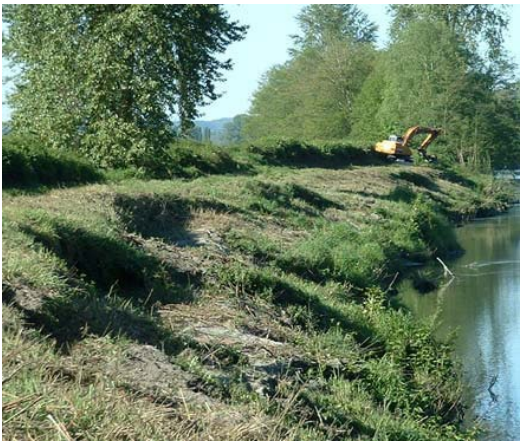
Description of Potential Risk and Assessment of Severity of Risk Issue		Potential Consequences		Details of any further investigations required	Possible rectification and prioritisation	Monitoring Program (if marginal risk only)	Assessment of Reliability of levee with Current Risks
		Short Term	Long Term				
✘	<p><b>Unacceptable</b> High water flows have eroded batter.</p>

Structural failure of levee.	Structural failure of levee.	<p>Refer to original construction specification for remediation guidelines. Check stability/integrity of levee section.</p>	<p>Immediate reinstatement of batters including topsoiling, reseeding and / or mulching or placing of turf strips where appropriate conditions exist. Investigate options for further stabilisation. <b>URGENT</b></p>	Monitor annually and during flood events after rectification	High risk of structural failure of levee

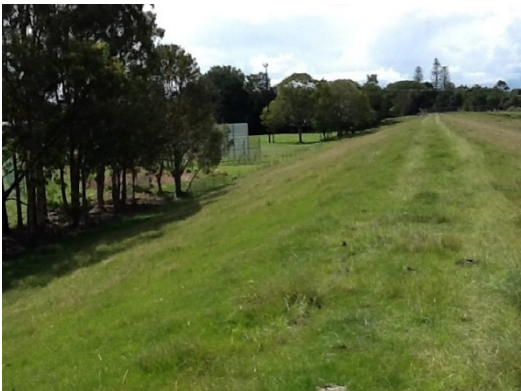
3.3	<b>Slumping of batters</b>						
✔	<p><b>Acceptable</b> Batter not steeper than design grade with no slumping.</p>

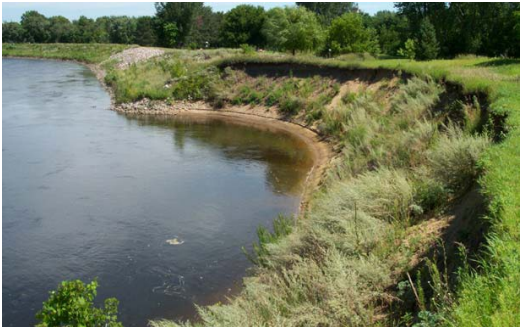
-	-	-	-	-	-
✘	<p><b>Unacceptable</b> Batter slumped due to water erosion (undercutting) at toe of levee.</p>

Structural failure of levee.	Structural failure of levee.	<p>Refer to original construction specification for remediation guidelines or alternatively consult structural engineer for re-design of levee. Check stability/integrity of levee section.</p>	<p>Immediate repair/stabilisation/reinstatement of river bank (gabions, rip rap etc.) and reinstatement of batters including topsoiling, reseeding and / or mulching or placing of strips of turf where appropriate conditions exist. Engineered re-design may be required <b>URGENT</b></p>	-	High risk of structural failure.
✘	<p><b>Unacceptable</b> Batter slumped due to too steep levee batter</p>

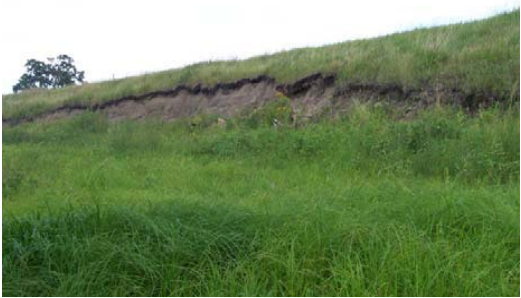
Structural failure of levee.	Structural failure of levee.	<p>Refer to original construction specification for remediation guidelines. Check stability/integrity of levee section.</p>	<p>Reconstruct batter at acceptable slope (new engineered design may be required). Ensure new works are keyed into existing structure.</p>	-	High risk of structural failure.

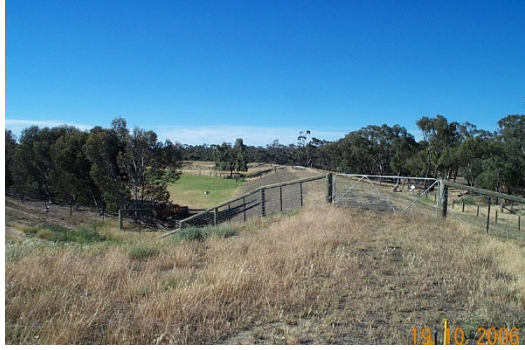
3.4	<b>Over steep batters</b>						
✓	<p><b>Acceptable</b> Batter installed as per design grade.</p>

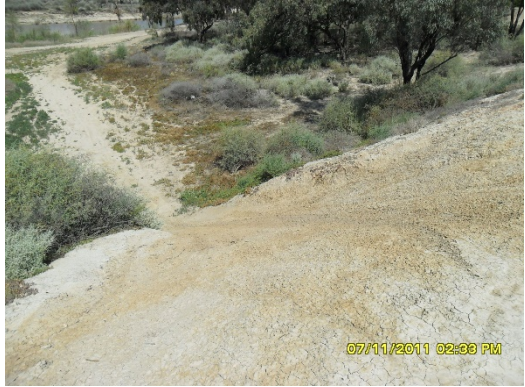
-	-	-	-	-	-
✗	<p><b>Unacceptable</b> Over steep batter due to incorrect design or erosion.</p>

Oversteep batters compounded by continued erosion of the bank due to runoff.	Slumping or major erosion of the batter.	Refer to original construction specification for remediation guidelines. Check stability/integrity of levee section.	High priority to reconstruct batter at acceptable grade and uniform profile (engineered redesign of levee batter grades). Ensure new works are keyed into existing structure.	Monitor annually and during flood events after rectification -	Moderate to High risk of structural failure.

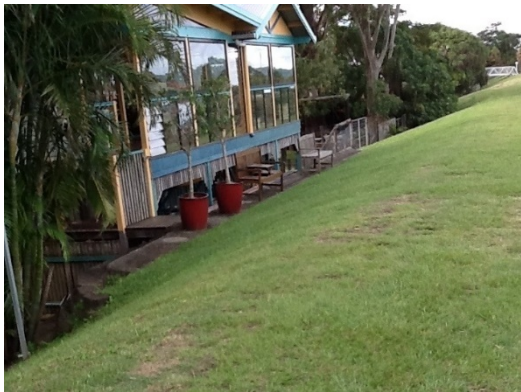
Description of Potential Risk and Assessment of Severity of Risk Issue			Potential Consequences		Details of any further investigations required	Possible rectification and prioritisation	Monitoring Program (if marginal risk only)	Assessment of Reliability of levee with Current Risks
			Short Term	Long Term				
±	<b>Marginal</b> Temporary structures on batters in Zone 1

Minimal	Interference with maintenance access and emergency services activities during flood event	The levee owner needs to have a policy in place to deal with temporary structures. No new structures shall be permitted in zone 1. Any structure removed from zone 1 shall not be replaced. Levee to be reinstated to appropriate condition when temporary structures removed	Existing temporary structures that do not impede the levee structure may be permitted.  Landholders to be informed that emergency services may destroy structures in a flood event. If maintenance is required landholder may need to move structure.	All temporary structures in zone 1 shall be recorded on a register following an initial audit. Levee owner policy to be enforced from this point on.	Easily removed structures pose a low threat to long term levee reliability if don't impinge on maintenance access to other areas.

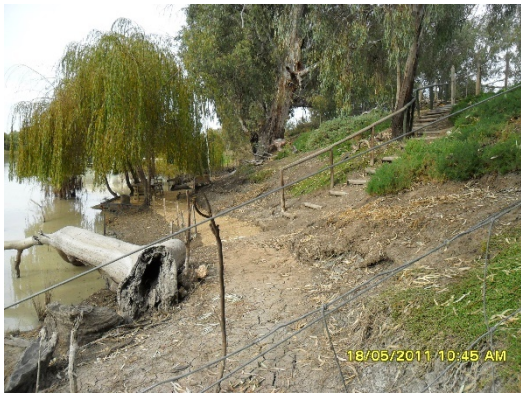
±	<b>Marginal</b> Structures in Zone 2 or 3

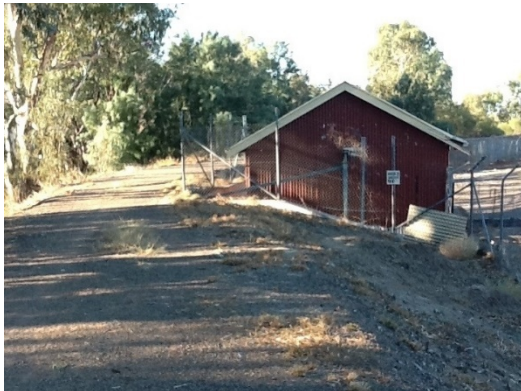
✘	<b>Unacceptable</b> Structures on Levee Crest

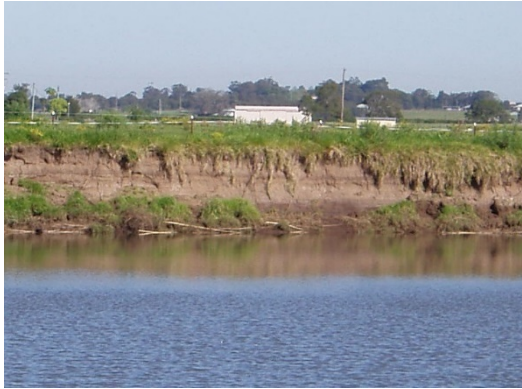
Description of Potential Risk and Assessment of Severity of Risk Issue		Potential Consequences		Details of any further investigations required	Possible rectification and prioritisation	Monitoring Program (if marginal risk only)	Assessment of Reliability of levee with Current Risks	
		Short Term	Long Term					
✘	<p><b>Unacceptable</b></p> <p>Major erosion / undercutting of levee bank and trees within 5m of the toe due to current, tide or wave action.</p>

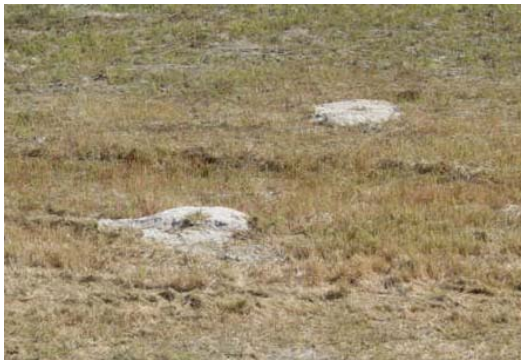
<b>3.7 Seepage under or through the Levee</b>								
✔	<p><b>Acceptable</b></p> <p>No identified seepage paths or sand boils.</p>	Insert Photo	-	-	-	-	-	-
±	<p><b>Marginal</b></p> <p>Potential sites identified as seepage paths (major trees, sand boils etc)</p>	Insert Photo	Minimal	Development into seepage paths	-	-	Monitor annually and during floods (sand boils are difficult to detect during routine inspections as they typically only appear during high water)	Moderate risk of seepage resulting in flooding in protected areas behind the levee during a flood event.
✘	<p><b>Unacceptable</b></p> <p>Seepage paths / sand boils positively identified.</p>

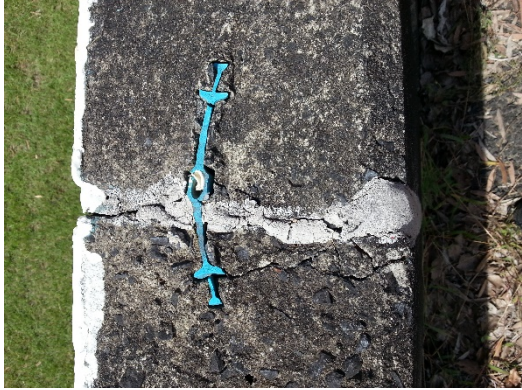
4.3	<b>Waterstops</b>							
✓	<b>Acceptable</b> Water stops intact

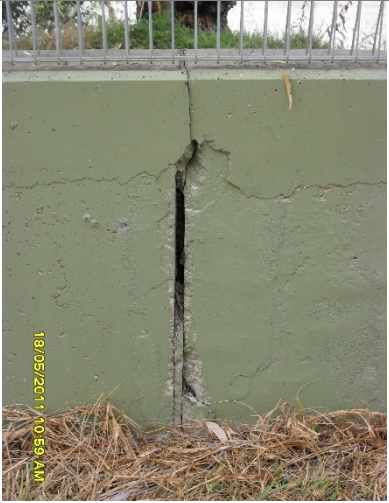
-	-	-	-	-	-
±	<b>Marginal</b> Water stop still intact however wall movement is such that water stop is stressed

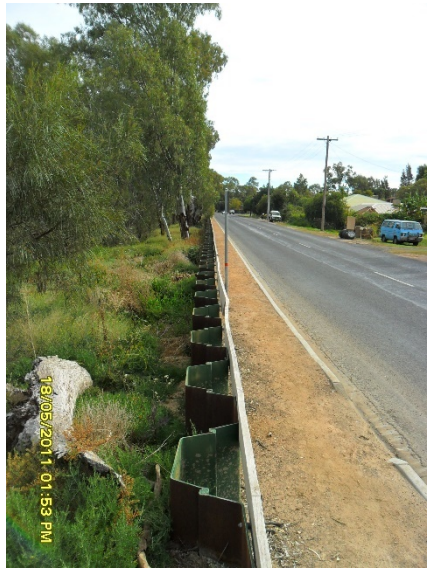
Description of Potential Risk and Assessment of Severity of Risk Issue		Potential Consequences		Details of any further investigations required	Possible rectification and prioritisation	Monitoring Program (if marginal risk only)	Assessment of Reliability of levee with Current Risks	
		Short Term	Long Term					
✘	<p><b>Unacceptable</b> Undermined / Exposed footings</p>	Insert Photo	<p>Collapse of concrete levee. Major breach</p>	<p>Collapse of concrete levee. Major breach</p>	<p>Engineer to inspect and recommend repair method</p>	<p>Immediately implement recommendations of Engineer. <b>URGENT</b></p>	-	High risk due to difficulty of repair during flood event.
<b>5.0 Sheet Pile Levee</b>								
<b>5.1 Wall Movement / Settlement</b>								
✓	<p><b>Acceptable</b> There is no settlement of the levee. No significant tilting or sliding of sheet pile wall.</p>

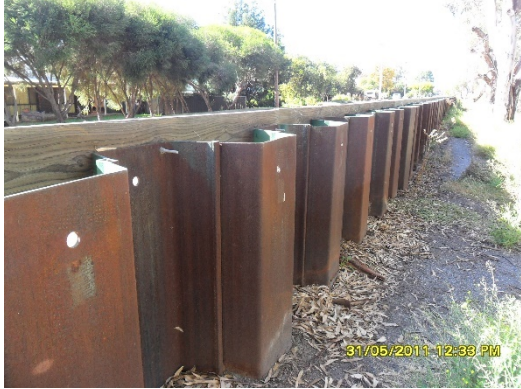
Description of Potential Risk and Assessment of Severity of Risk Issue		Potential Consequences		Details of any further investigations required	Possible rectification and prioritisation	Monitoring Program (if marginal risk only)	Assessment of Reliability of levee with Current Risks	
		Short Term	Long Term					
<b>5.2 Surface appearance</b>								
✓	<b>Acceptable</b> Minimal rust

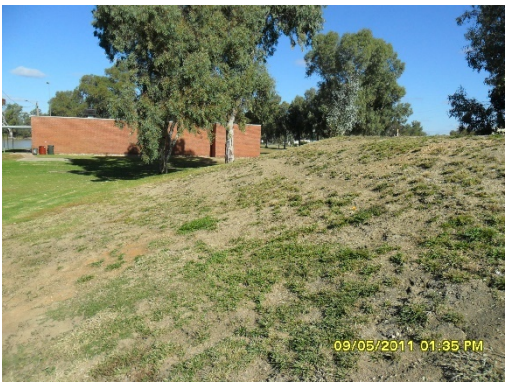
Description of Potential Risk and Assessment of Severity of Risk Issue		Potential Consequences		Details of any further investigations required	Possible rectification and prioritisation	Monitoring Program (if marginal risk only)	Assessment of Reliability of levee with Current Risks	
		Short Term	Long Term					
±	<p><b>Marginal</b></p> <p>Greater than 50% but less than 90% of surface area of the earth levee batter which is subject to receipt of rainfall runoff from the crest of the levee, covered by grass.</p> <p>Individual patches of bare ground showing minor effects of erosion.</p>

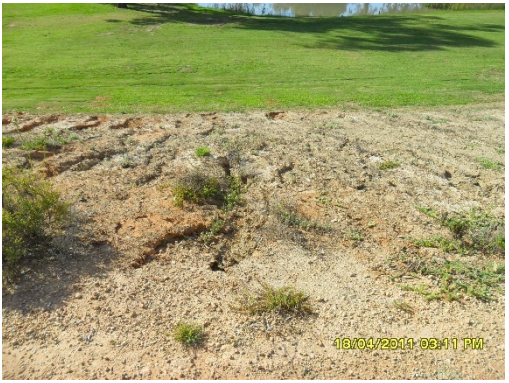
✘	<p><b>Unacceptable</b></p> <p>Less than 50% of surface area of the earth levee batter which is subject to receipt of rainfall runoff from the crest of the levee, covered by grass.</p>

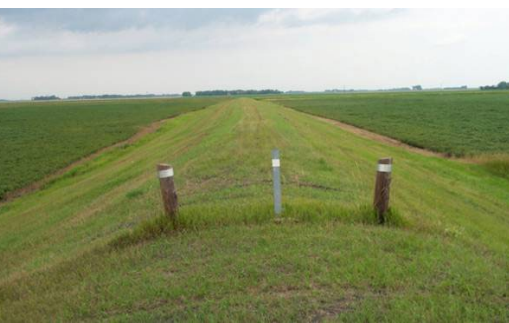
6.2	<b>Trees / shrubs growing on levees (i.e. within Zone 1)</b>							
✓	<p><b>Acceptable</b></p> <p>No trees or shrubs growing on levee. (In Zones 1, 2 &amp; 3)</p> <p><i>Note: That this photo shows unacceptable access to levee (see Section on Access to levee).</i></p>

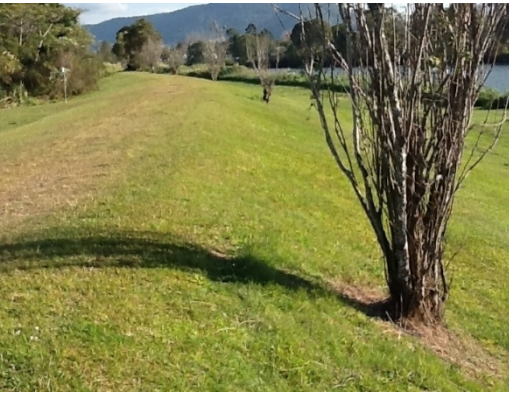
-	-	-	-	-	-
±	<p><b>Marginal</b></p> <p>Small shrubs / trees</p>

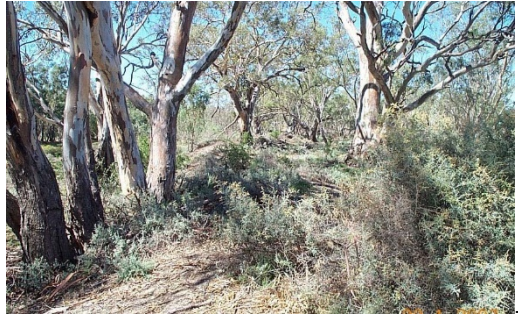
Description of Potential Risk and Assessment of Severity of Risk Issue		Potential Consequences		Details of any further investigations required	Possible rectification and prioritisation	Monitoring Program (if marginal risk only)	Assessment of Reliability of levee with Current Risks	
		Short Term	Long Term					
✘	<p><b>Unacceptable</b></p> <p>Trees / woody shrubs growing on levee bank (as it is uncertain to ascertain the effect on the structural integrity of the levee bank).</p>

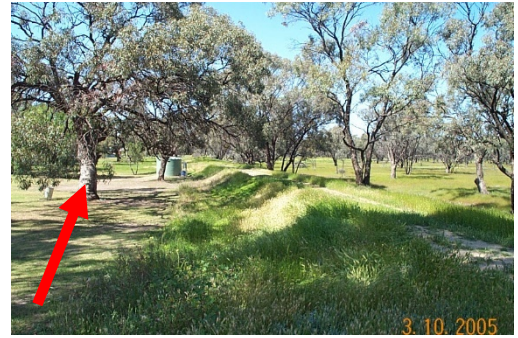
✔	<p><b>Acceptable</b></p> <p>Trees / shrubs greater than 5m away from toe of levee.</p>

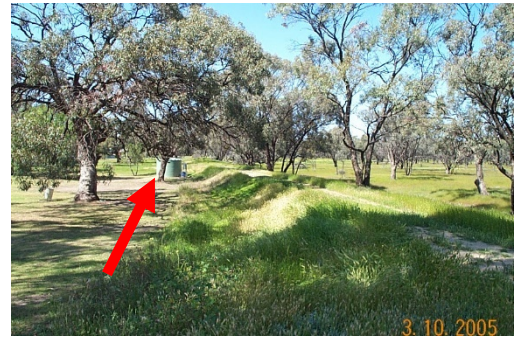
-	-	-	-	-	-
±	<p><b>Marginal</b></p> <p>Trees / shrubs between 2m-5m away from toe of levee and the drip zone is not within zone 1.</p>

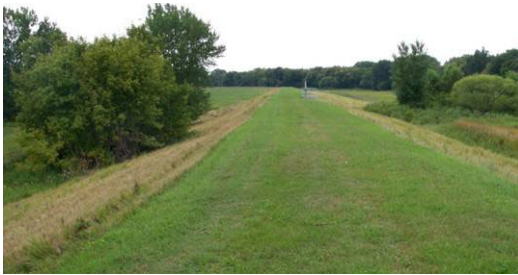
Minimal.	Tree collapse during flood event could threaten structural integrity of levee system.	<p>Confirm impact of tree root zone on levee.</p> <p>Horticulturalist <u>may</u> be required to provide health check on all trees in zones 2 and 3.</p> <p>Seek all necessary approvals in relation to vegetation removal</p>	Where permissible remove trees in cyclical removal program considering horticulturalists advice.	If restrictions apply add to monitoring and removal program.	While trees are healthy low to moderate risk of effecting reliability.
✘	<p><b>Unacceptable</b></p> <p>Trees / shrubs less than 2m away from Levee Zone 1. (Refer tree philosophy).</p>

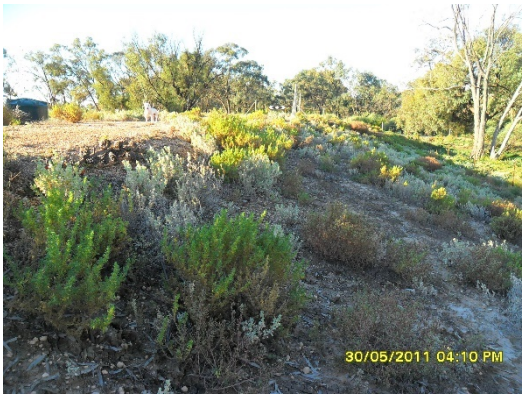
Description of Potential Risk and Assessment of Severity of Risk Issue		Potential Consequences		Details of any further investigations required	Possible rectification and prioritisation	Monitoring Program (if marginal risk only)	Assessment of Reliability of levee with Current Risks	
		Short Term	Long Term					
<b>7.0 Animal Burrows</b>								
<b>7.1 Rabbit / Fox / Echidna holes etc.</b>								
✓	<p><b>Acceptable</b></p> <p>No animal burrows in Levee. No animal burrow within 5m of Zone 1.</p>

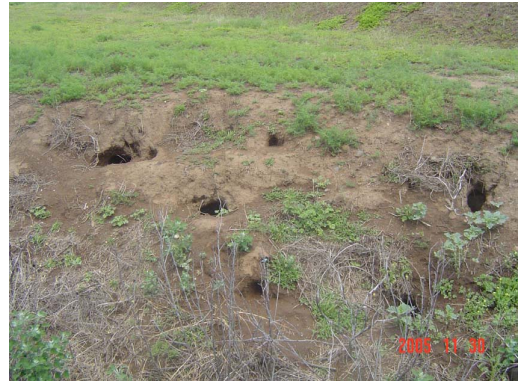
✗	<p><b>Unacceptable</b></p> <p>Animal burrows of any kind within levee Zone 1. Major animal burrows in Zone 2 or 3</p>

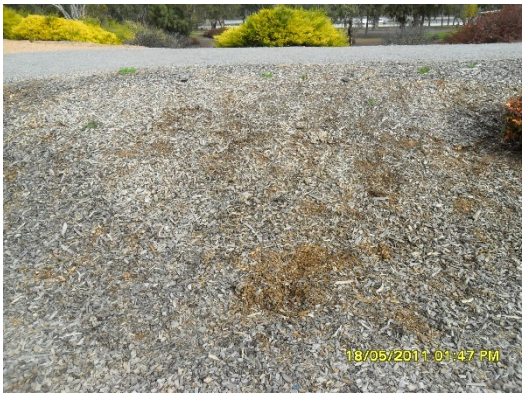
Possible seepage issues through levee.	Large burrows could cause levee to fail during flood event.	Refer to original construction specification for remediation guidelines.	Burrows will require total excavation to determine extent of burrow prior to remediation.	-	Moderate to high risk of causing seepage path through levee. If this occurred damage would be quite significant.
<b>7.2 Ant Nests</b>								
✓	<p><b>Acceptable</b></p> <p>No ant nests.</p>

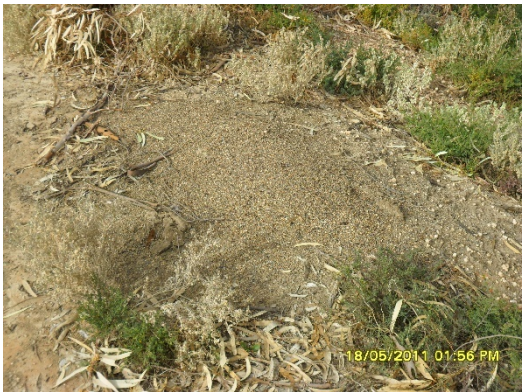
Description of Potential Risk and Assessment of Severity of Risk Issue			Potential Consequences		Details of any further investigations required	Possible rectification and prioritisation	Monitoring Program (if marginal risk only)	Assessment of Reliability of levee with Current Risks
			Short Term	Long Term				
±	<p><b>Marginal</b></p> <p>Ant nest on town side batter slope. Smaller ant nests on crest or river side batter.</p>

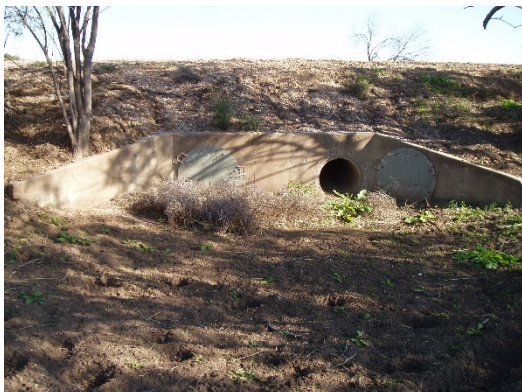
-	-	-	-	-	-
±	<p><b>Marginal</b></p> <p>Closure structures that cannot being operated or accessed during flood events e.g. metal plates Structures subject to repeated vandalism.</p>

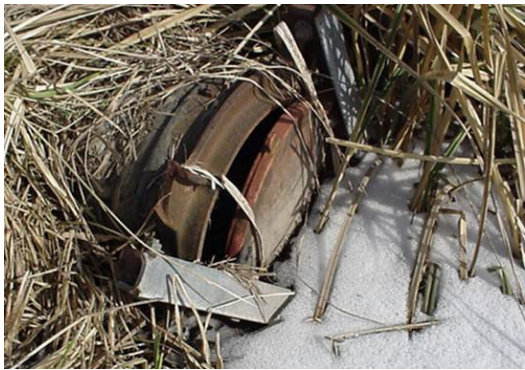
Description of Potential Risk and Assessment of Severity of Risk Issue		Potential Consequences		Details of any further investigations required	Possible rectification and prioritisation	Monitoring Program (if marginal risk only)	Assessment of Reliability of levee with Current Risks	
		Short Term	Long Term					
✘	<p><b>Unacceptable</b></p> <p>Any closure mechanism not fully functioning (worn, damaged or bent).</p> <p>Any impedance of obstruction to closure mechanism.</p> <p>Gate seals leaking or damaged.</p> <p>Location is likely to be exposed to perpendicular flows which may force gate open or tear the gate from its hinges. (Lack of protection due to insufficient wing walls and / or headwalls.)</p>

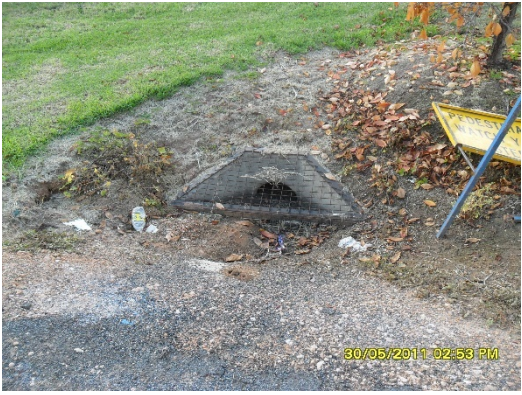
<p><b>Imminent Threat</b></p> <p>Stormwater pipes with no closure mechanism.</p>

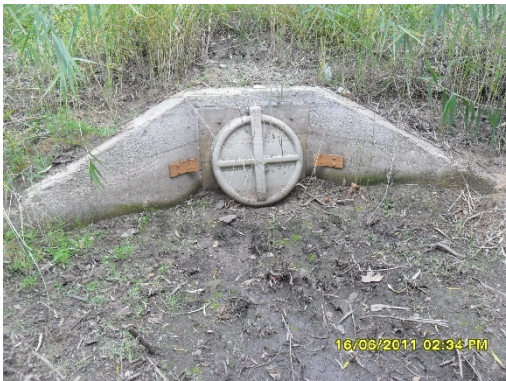
<b>8.2 Impedance to flow capacity</b>								
✓	<p><b>Acceptable</b></p> <p>Pipe is not silted up and full pipe available to convey stormwater.</p>	Insert photo.	-	-	-	-	-	-
±	<p><b>Marginal</b></p> <p>Pipe partially silted up only marginally impeding stormwater.</p> <p>Note: photo also shows impact on closure mechanism as discussed separately above.</p>

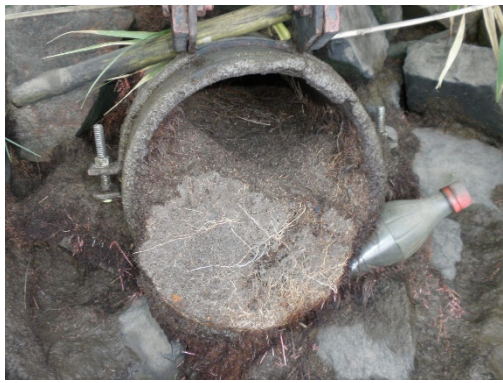
Description of Potential Risk and Assessment of Severity of Risk Issue		Potential Consequences		Details of any further investigations required	Possible rectification and prioritisation	Monitoring Program (if marginal risk only)	Assessment of Reliability of levee with Current Risks	
		Short Term	Long Term					
✘	<p><b>Unacceptable</b></p> <p>Pipe silted up impeding stormwater.</p> <p>Note: Photo also shows a lack of floodgates as discussed separately above</p>

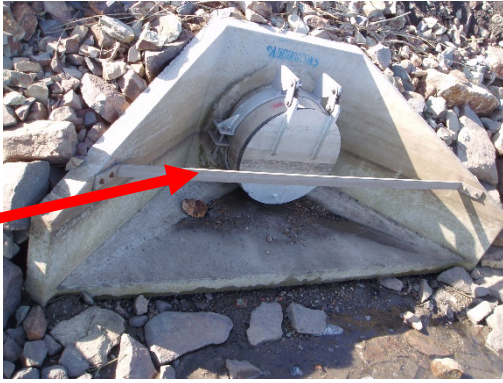
<b>8.3 Vegetation</b>								
✔	<p><b>Acceptable</b></p> <p>Minimal vegetation at inlet / outlet. Flow not impeded. Operation of closure mechanism not impeded.</p> <p>Note: Photo shows a manually bolted-on horizontal crossbeam, seemingly to ensure that the flap valve is closed. This practice is <u>not recommended</u> as subsequent levee "internal" flooding could occur if operators forget to remove the crossbeam after the subsidence of river flooding.</p>

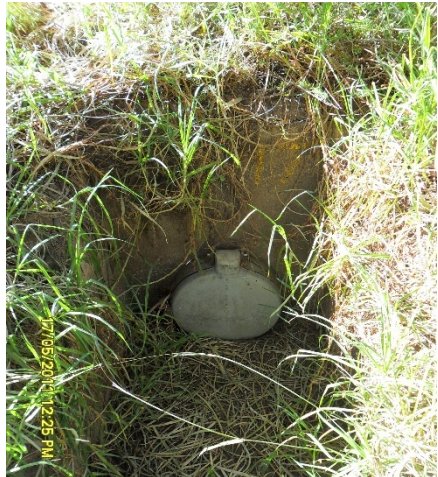
-	-	-	-	-	-
±	<p><b>Marginal</b></p> <p>Moderate volume of vegetation impeding flow into stormwater structures but closure mechanism operable.</p>

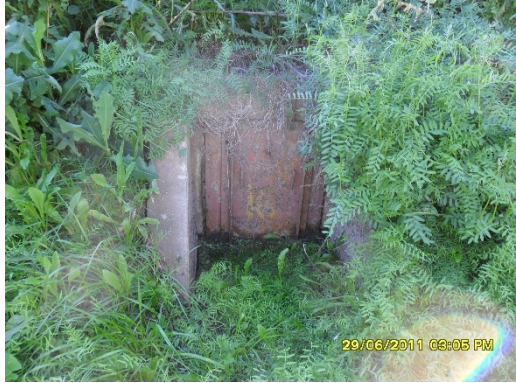
Description of Potential Risk and Assessment of Severity of Risk Issue		Potential Consequences		Details of any further investigations required	Possible rectification and prioritisation	Monitoring Program (if marginal risk only)	Assessment of Reliability of levee with Current Risks	
		Short Term	Long Term					
✘	<p><b>Unacceptable</b></p> <p>Flow and Operation of closure mechanism impeded.</p>

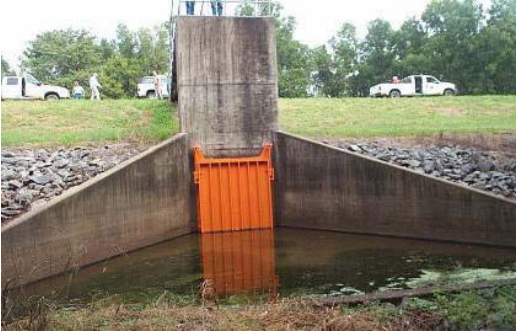
8.4	<b>Structural integrity</b>							
✓	<p><b>Acceptable</b></p> <p>Pipes, headwalls or pits are in good, sound condition with no cracks or openings between joints.</p>

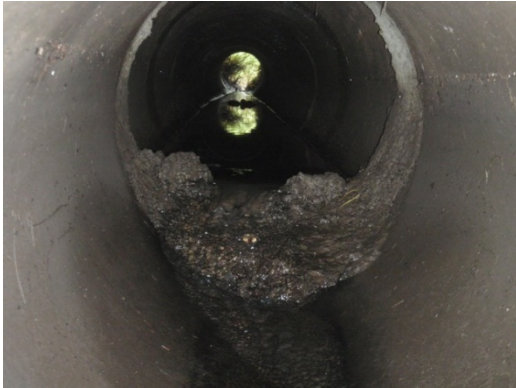
-	-	-	-	-	-
±	<p><b>Marginal</b></p> <p>Pipes, headwalls or pits with minor structural issues.</p> <p>Closure mechanism and stormwater pipe must be sound as discussed separately above.</p>	<p>Insert Photo</p>	<p>Minimal</p>	<p>Further deterioration could lead to piping / structural failures which could lead to protection not being achieved for the design flood.</p>	<p>Engineer to inspect and provide recommendations for repair / replacement.</p>	<p>Repair or replace pipes, headwalls and/or pits as per engineer's recommendations. Depending on recommendation work could be added to cyclical maintenance program.</p>	<p>Monitor annually and after a flood event</p>	<p>Low to moderate risk of structural issues.</p>
✘	<p><b>Unacceptable</b></p> <p>Pipes, headwalls or pits structurally unsound. Issues can include pipe joint displacement (see photograph), corrosion, cracking etc.</p>

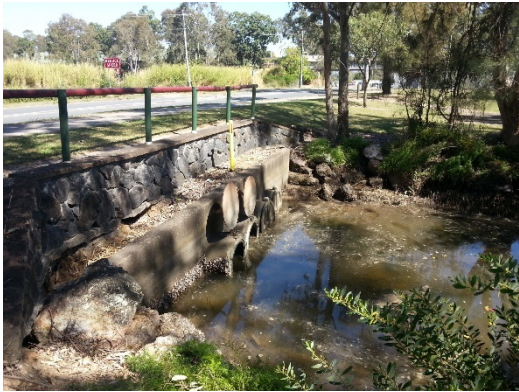
8.5	<b>Erosion of the Levee at Inlets and Outlets</b>							
✓	<p><b>Acceptable</b></p> <p>There is no active erosion or bank collapse at outlet or inlet.</p>

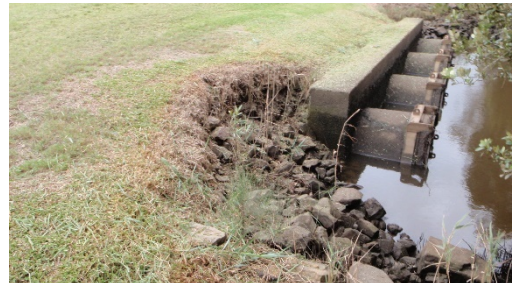
-	-	-	-	-	
±	<p><b>Marginal</b></p> <p>There is some erosion or bank collapse at outlet or inlet but the integrity of the levee not threatened.</p>

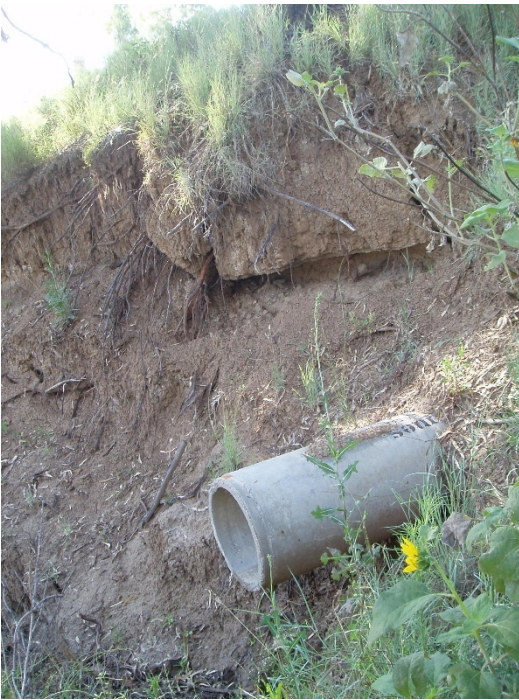
Minimal	Further erosion could lead to structural issues of levee.	Original construction specification to be consulted for remediation of levee structure for major erosion. Clay material with the same properties as the original levee to be used for repairs.  Rock protection should also be considered.	Repair and / or add rock protection around inlet and outlet ASAP	Repair and monitor annually or after a flood event	Low to moderate risk of levee failure
✗	<p><b>Unacceptable</b></p> <p>The levee surrounding the outlet or inlet has failed.</p>

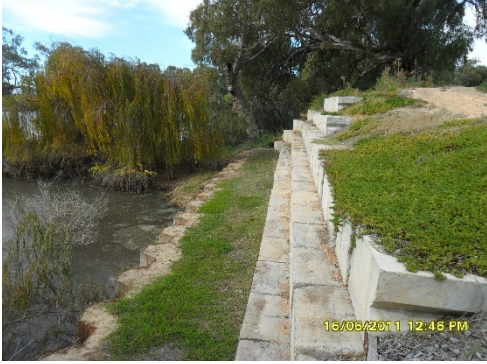
Description of Potential Risk and Assessment of Severity of Risk Issue		Potential Consequences		Details of any further investigations required	Possible rectification and prioritisation	Monitoring Program (if marginal risk only)	Assessment of Reliability of levee with Current Risks	
		Short Term	Long Term					
<b>9.0 Retaining Walls</b>								
<b>9.1 Retaining Wall (as Levee and Supporting Levee)</b>								
✓	<p><b>Acceptable</b></p> <p>No significant tilting or sliding of wall.</p>

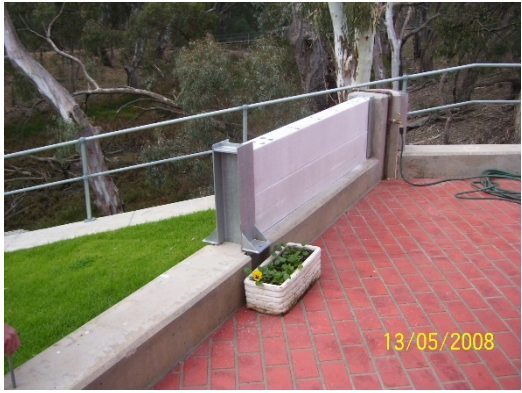
Description of Potential Risk and Assessment of Severity of Risk Issue		Potential Consequences		Details of any further investigations required	Possible rectification and prioritisation	Monitoring Program (if marginal risk only)	Assessment of Reliability of levee with Current Risks	
		Short Term	Long Term					
<b>10.0 Ancillary Equipment</b>								
<b>10.1 Closure structures (There are numerous types of these structures. They are usually used in levee openings that need to remain open during non-flood times e.g. roads. Commonly in the form of temporary levees, floodgates, earth stockpiles, flood barriers, etc.)</b>								
✓	<p><b>Acceptable</b></p> <p>Closure structure in good repair.</p> <p>Closure equipment (e.g. stop logs, flood gates or other materials) are available.</p> <p>Components are clearly marked and installation instructions / procedures available.</p>

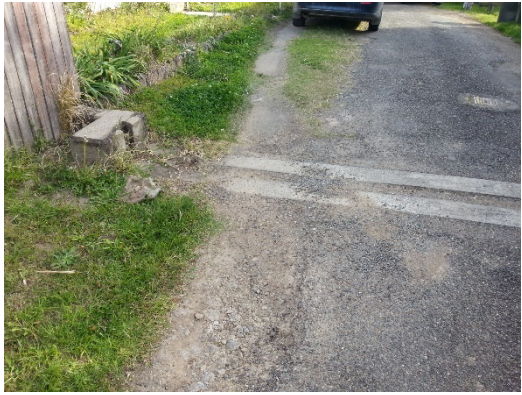
±	<p><b>Marginal</b></p> <p>Closure structure in good repair.</p> <p>Closure equipment (e.g. stop logs, flood gates or other materials) are available.</p> <p>Operations manuals not available.</p>	Insert Photo	Minimal	Confusion preceding flood event.	Find / update operations manual.	Store operations manual in central register (readily available). Train key staff in operational requirements of levee.	Check annually and in the lead up to a flood to see that all components are still in sound order	Low to moderate risk of not being able to be placed effectively during flood event leading to a flood breaching the levee.
✗	<p><b>Unacceptable</b></p> <p>Closure structure in poor repair.</p> <p>Closure equipment (e.g. stop logs, flood gates or other materials) are not readily available.</p> <p>Components are not clearly marked or installation instructions / procedures not available.</p>

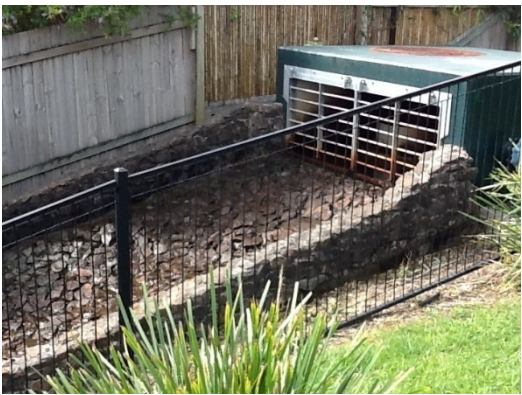
<b>10.2 Flood Pumps / Pumping Stations</b>								
✓	<p><b>Acceptable</b></p> <p>The levee owner has adequate flood pumps (allocated for flood event purposes) regularly serviced and in good working order.</p> <p>Pump stations are regularly audited (as per O&amp;M manual) to ensure pumps, pipes, valves and switchboards are maintained and operational and fuel is fresh (if required). If dual fuel (electricity and petrol) then check the battery is fully charged to crank the engine.</p>

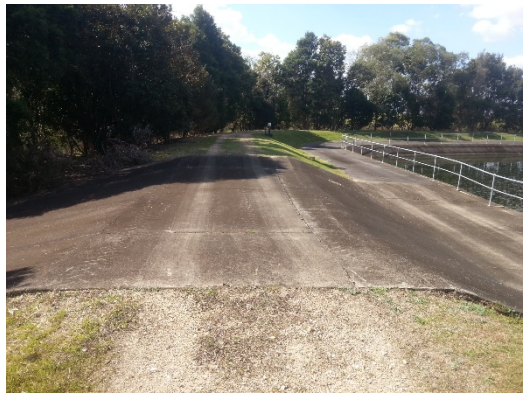
<b>11.0 Spillways</b>								
<b>11.1 Spillway condition</b>								
✔	<p><b>Acceptable</b></p> <p>No slumping / erosion of crest level. Erosion protection is still in place.</p> <p>Spillway operational with no defects (all materials).</p>

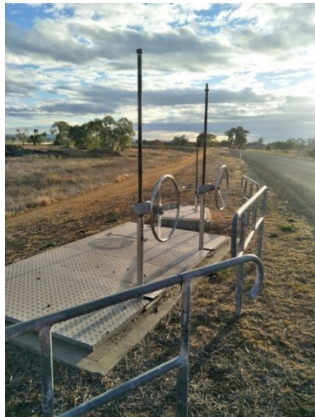
<b>12.0 Work, Health &amp; Safety (WHS)</b>								
<b>12.1 Culvert Floodgate – Access and Operability</b>								
✔	<p><b>Acceptable</b></p> <p>Clear access to floodgate. Presence of warning signage. Operable structures / devices locked and secured. Applied operation force of floodgate handwheel adequately less than 130 N.</p>

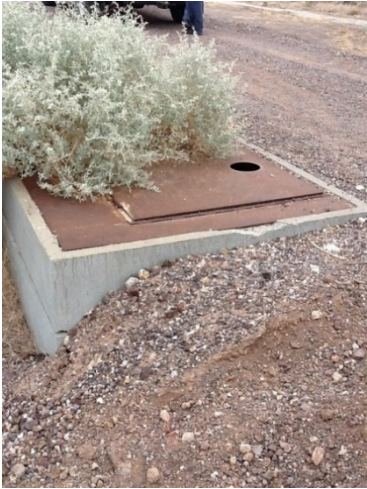
Description of Potential Risk and Assessment of Severity of Risk Issue		Potential Consequences		Details of any further investigations required	Possible rectification and prioritisation	Monitoring Program (if marginal risk only)	Assessment of Reliability of levee with Current Risks	
		Short Term	Long Term					
±	<p><b>Marginal</b></p> <p>Access to floodgate slightly impeded by vegetation and / or other unwanted items. Structure / device operable and covered but not locked. Applied operation force of floodgate handwheel requiring over 130 N.</p>

<p>Floodgate accessible but with inconvenience during operation and maintenance.</p> <p>Risk of damage from vandalism.</p>	←	---	<p>Completely remove all obstructions to ensure safe access to floodgate. Provide locking mechanism.</p>	<p>Must be monitored and maintained frequently as obstructions can cause injuries and internal flooding:</p> <ul style="list-style-type: none"> <li>• General Inspections;</li> <li>• Operational (annual) Inspections;</li> <li>• Pre-Flood Inspections;</li> <li>• Visual Audits.</li> </ul>	<p>Reliable but with minor disturbance and delay (if not damaged by the public).</p>

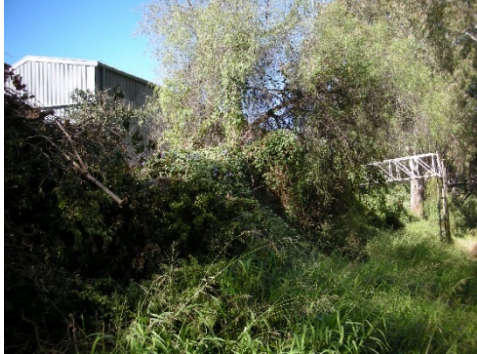
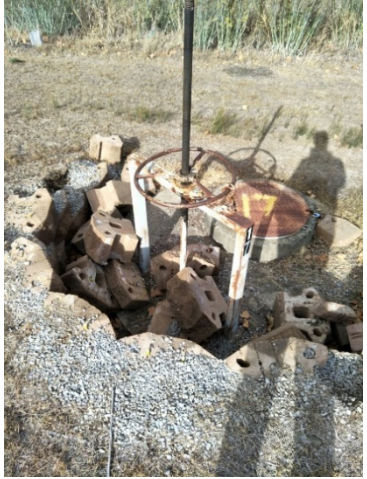
✘	<p><b>Unacceptable</b></p> <p>Access to floodgate severely impeded by overgrown vegetation and / or other foreign items. Structure / device could be operable but not locked. Absence of warning signage. Required applied operation force of floodgate handwheel significantly greater than 130 N or inoperable.</p>

<p>Floodgate inaccessible and hence not able to be operated leading to floodwater intrusion from river into town.</p>	←	---	<p>Completely remove all obstructions to ensure safe access to floodgate immediately.</p>	<p>Must be monitored and maintained frequently as obstructions can cause injuries and internal flooding:</p> <ul style="list-style-type: none"> <li>• General Inspections;</li> <li>• Operational (annual) Inspections;</li> <li>• Pre-Flood Inspections;</li> <li>• Visual Audits.</li> </ul>	<p>Unreliable</p>

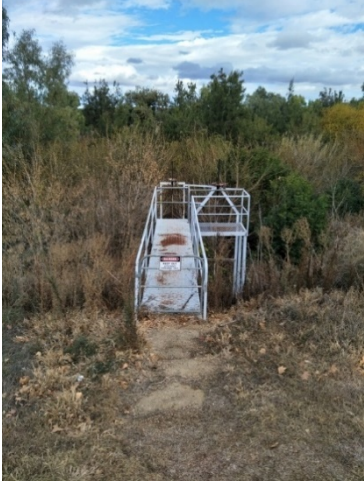
12.2	<b>Culvert Floodgate – Elevated Floodgate Platform Walkway</b>						
✓	<p><b>Acceptable</b></p> <p>Walkway width and accessories (e.g. handrails (incl. of in front of floodgate handwheel), floor grating) in full compliance with AS 1657 – Fixed platforms, walkways, stairways and ladders – Design, construction and installation. Platform soundly founded on the levee batter / river bank.</p> <p>Floodgate and lifting frame securely installed on outlet structure / platform.</p>

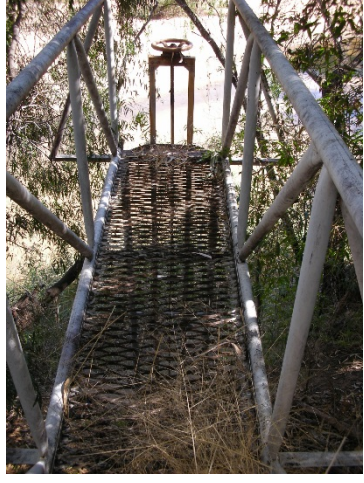
---	---	---	---	<ul style="list-style-type: none"> <li>Operational (annual) Inspections as a minimum;</li> <li>Pre-Flood Inspections;</li> <li>Visual Audits.</li> </ul> <p>No issues</p>
±	<p><b>Marginal</b></p> <p>Walkway width and accessories (e.g. handrails, floor grating) in minor non-compliance with AS 1657. Platform currently soundly founded on the levee batter / river bank but structural members showing signs of deterioration. Stability acceptable in the short term.</p> <p>Floodgate and lifting frame observed to be loosening with some bolts / anchors missing.</p>

Platform accessible but standards of accessories outdated. Walkway too narrow, handrails too short and floor grating deteriorating, etc. Risk of Operators suffering from minor to moderate injuries.	←	Review AS 1657 and other relevant standards. Specific engineering assessment of platform's structural members and floodgate accessories.	Replace all sub-standard items to ensure safe access to and operation of floodgate prior to flood season.	<p>Must be monitored and maintained frequently as instability can cause injuries and internal flooding:</p> <ul style="list-style-type: none"> <li>General Inspections;</li> <li>Operational (annual) Inspections;</li> <li>Pre-Flood Inspections;</li> <li>Visual Audits.</li> </ul> <p>Reliable but with risk of Operators suffering from minor to moderate injuries.</p>
