Public Works  
Advisory

# Development of Methodology and Visual Audit for Urban Levees

Report Number: ISR20177

December 2020

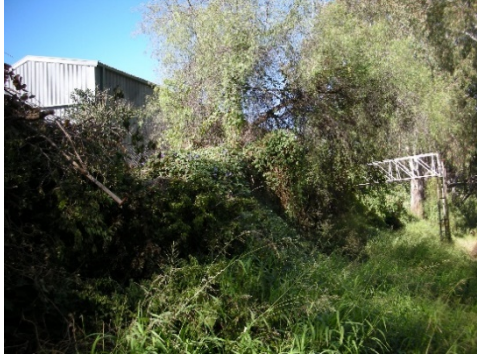
✗	<p><b>Unacceptable</b></p> <p>Minimal safety features present. Floor gratings missing. Questionable stability (e.g. no intermediate piers). Undermining of platform piers on bank. Structural members observed to be unlevel, leaning, bending, buckling, loosening, etc. Platform and floodgate on the verge of collapse.</p>

Imminent complete destruction of platform which would destroy floodgate and result in loss of lives.	←	----	Redesign and reconstruct entire structure to ensure safe access to floodgate immediately.	<p>Must be monitored and maintained frequently as instability can cause injuries and internal flooding:</p> <ul style="list-style-type: none"> <li>General Inspections;</li> <li>Operational (annual) Inspections;</li> <li>Pre-Flood Inspections;</li> <li>Visual Audits.</li> </ul> <p>Unreliable (high risk of fatalities)</p>

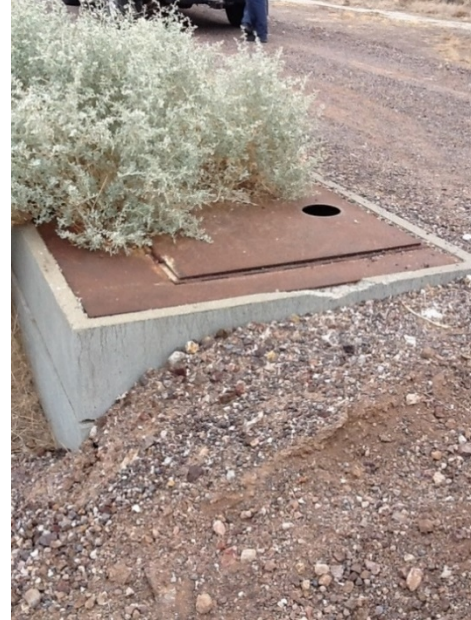
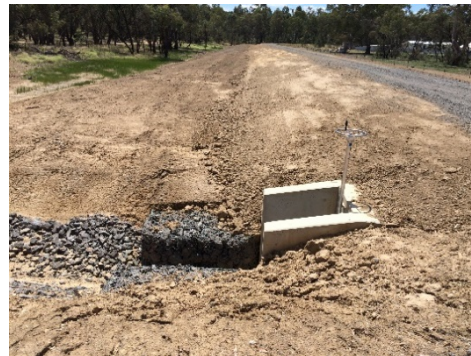
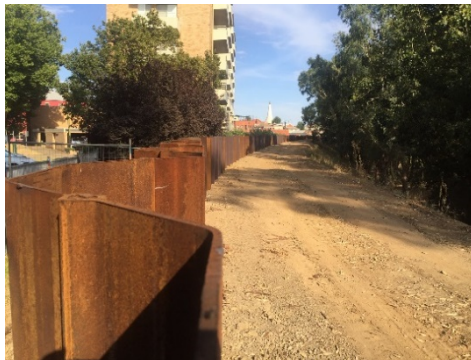
Description of Potential Risk and Assessment of Severity of Risk Issue	Potential Consequences		Details of any further investigations required	Possible rectification and prioritisation	Monitoring Program (if marginal risk only)	Assessment of Reliability of levee with Current Risks
	Short Term	Long Term				
<p>12.3 Trip Hazards</p> <p><b>Acceptable</b></p> <p>Absence of any solid items protruding &gt; 5 mm and &lt; 900 mm (AS 1657).</p> <p>Crest of floodgate structure flushed with ground access surface.</p> <p>Presence of hand / guardrails to advise and prevent tripping.</p> <p>Specific structures (e.g. sheet pile wall) installed at ≥ 900 mm height to eliminate trip hazard.</p>	---	---	---	---	<ul style="list-style-type: none"> <li>Operational (annual) Inspections as a minimum;</li> <li>Pre-Flood Inspections;</li> <li>Visual Audits.</li> </ul>	No issues

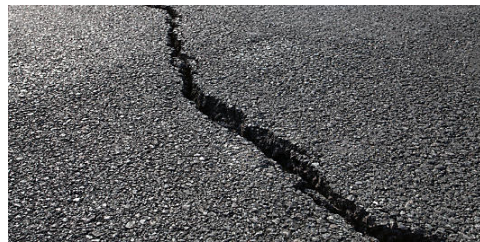
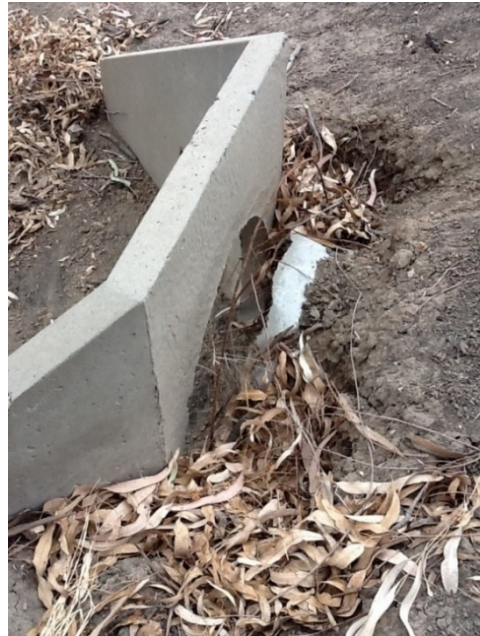
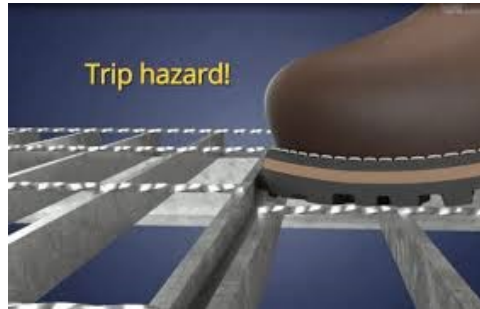
Description of Potential Risk and Assessment of Severity of Risk Issue	Potential Consequences		Details of any further investigations required	Possible rectification and prioritisation	Monitoring Program (if marginal risk only)	Assessment of Reliability of levee with Current Risks	
	Short Term	Long Term					
<p><b>Marginal</b></p> <p>Presence of minor trip items (&lt; 100 mm) that may not be obvious on levee and broken / displaced parts of appurtenant structures (e.g. floor gratings, unloaded retaining structures).</p> <p>Absence of hand / guardrails to advise and prevent tripping for features that cannot be levelled out flat.</p>

<p>Minor to moderate trip and fall injuries.</p>	<p>←</p>	<p>---</p>	<p>Level out the surfaces as soon as possible.</p>	<p>Must be monitored and maintained frequently as trips can injure Operators and public;</p> <ul style="list-style-type: none"> <li>• General Inspections;</li> <li>• Operational (annual) Inspections;</li> <li>• Pre-Flood Inspections;</li> <li>• Visual Audits.</li> </ul>	<p>Reliable (marginal for some cases) but with risk of Operators suffering from minor to moderate injuries.</p>

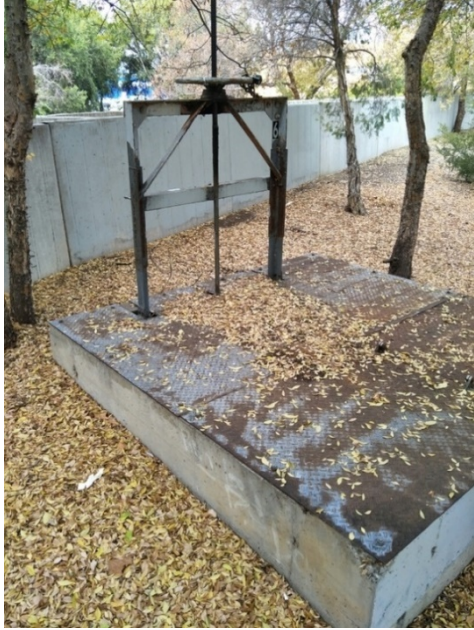
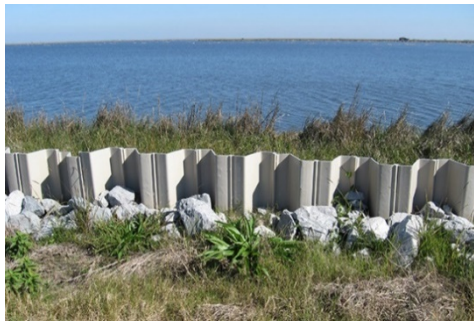
Description of Potential Risk and Assessment of Severity of Risk Issue		Potential Consequences		Details of any further investigations required	Possible rectification and prioritisation	Monitoring Program (if marginal risk only)	Assessment of Reliability of levee with Current Risks
		Short Term	Long Term				
<p><b>Unacceptable</b></p> <p>✘ Obvious major trip hazards of any temporary / permanent solid structural items up to 900 mm in height that cannot be levelled out.</p>

<p>Moderate to major trip and fall injuries.</p>	<p>←</p>	<p>Specific safety and / or structural review may be required.</p>	<p>Install hand / guardrail protection or steps if through access is required immediately.</p>	<p>Must be monitored and maintained frequently as trips can injure Operators and public;</p> <ul style="list-style-type: none"> <li>• General Inspections;</li> <li>• Operational (annual) Inspections;</li> <li>• Pre-Flood Inspections;</li> <li>• Visual Audits.</li> </ul>	<p>Unreliable (high risk of moderate injuries)</p>

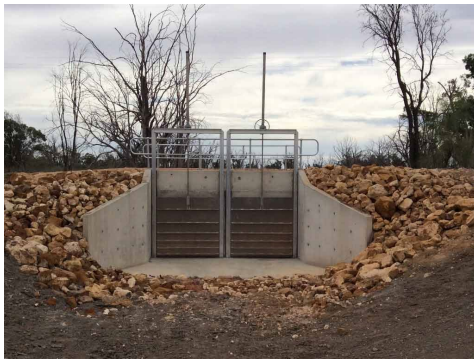
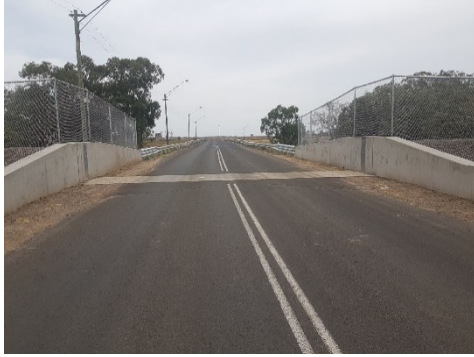
<p>12.4</p>	<p><b>Fall Hazards</b></p> <p>WHS Regulations 291: 18 High Risk Work Activities – Item 1 considers the potential of a person falling more than 2 m to be a “high-risk activity”. However, the risk of non-fatal injuries (e.g. rolling / twisting of ankle / wrist, broken limbs and unconsciousness due to head knock) remains present from falling from heights less than 2 m. Levee owners should act in accordance to the regulation to eliminate / mitigate all risks according to the ALARP principle.</p>						
<p>✔</p>	<p><b>Acceptable</b></p> <p>Direct vertical elevation drop ≥ 300 mm (culvert floodgate structures, flood barrier road crossings, etc.) protected with hand / guardrails or man proof fencing to prevent falling or steps provided in accordance with AS 1657.</p>

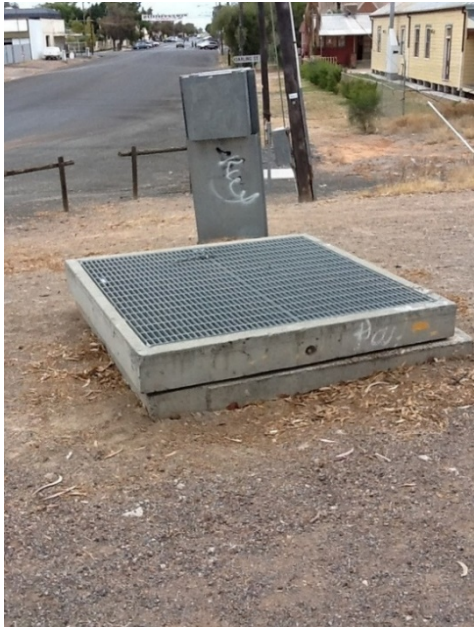
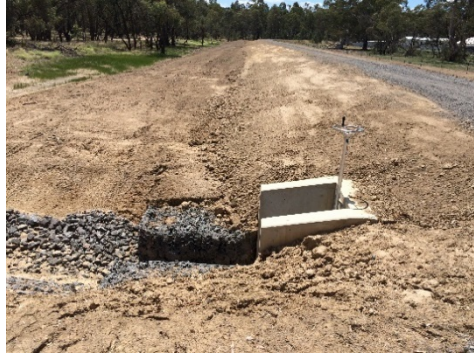
±	<p><b>Marginal</b></p> <p>Direct vertical elevation drop &lt; 900 mm (culvert floodgate structures, flood barrier road crossings, etc.) not protected with hand / guardrails or man proof fencing to prevent falling or no steps provided in accordance with <u>AS 1657</u>.</p> <p>In some cases, could also be considered 'unacceptable' trip hazard.</p>

<p>Fall from crest of structure resulting in minor to moderate injuries.</p>	<p>←</p> <p>Specific safety and / or structural review may be required.</p>	<p>Install hand / guardrail protection or steps as soon as possible.</p>	<p>Must be monitored and maintained frequently as falls can injure Operators and public:</p> <ul style="list-style-type: none"> <li>• General Inspections;</li> <li>• Operational (annual) Inspections;</li> <li>• Pre-Flood Inspections;</li> <li>• Visual Audits.</li> </ul>	<p>Unreliable (high risk of minor injuries)</p>

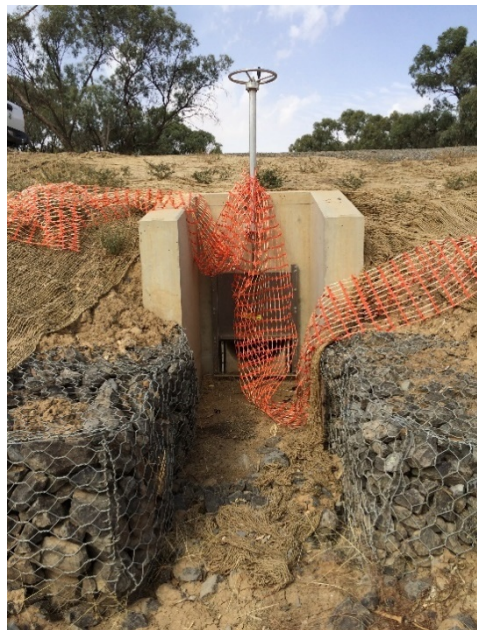
Description of Potential Risk and Assessment of Severity of Risk Issue		Potential Consequences		Details of any further investigations required	Possible rectification and prioritisation	Monitoring Program (if marginal risk only)	Assessment of Reliability of levee with Current Risks	
		Short Term	Long Term					
✘	<p><b>Unacceptable</b></p> <p>Direct vertical elevation drop &gt; 900 mm (culvert floodgate structures, flood barrier road crossings, etc.) not protected with hand / guardrails or man proof fencing to prevent falling or no steps provided in accordance with <u>AS 1657</u>.</p>

<p>Fall from crest of structure resulting in moderate to major injuries.</p>	<p>←</p>	<p>Specific safety and / or structural review may be required.</p>	<p>Install hand / guardrail protection or steps immediately.</p>	<p>Must be monitored and maintained frequently as falls can injure Operators and public:</p> <ul style="list-style-type: none"> <li>• General Inspections;</li> <li>• Operational (annual) Inspections;</li> <li>• Pre-Flood Inspections;</li> <li>• Visual Audits.</li> </ul>	<p>Unreliable (high risk of major injuries)</p>

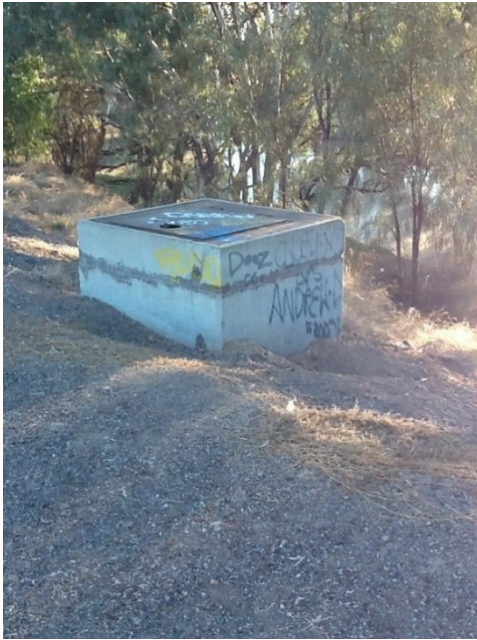
12.5	<p><b>Confined Spaces</b></p> <p>“Confined Spaces” is not specific for pits and shafts. Its full description is defined in AS 2865.</p>							
✔	<p><b>Acceptable</b></p> <p>Confined spaces with the presence of designated entry and exit points. Adequately covered / closed and locked to prevent accidental / unauthorised access.</p> <p>Operators are appropriately trained for entry (confined space entry permit) and possess adequate contemporary safe entry equipment such as:</p> <ul style="list-style-type: none"> <li>• Tripods with winches.</li> <li>• Body harnesses.</li> <li>• Breathing apparatus.</li> <li>• Portable firefighting equipment.</li> <li>• Gas detection devices.</li> </ul>

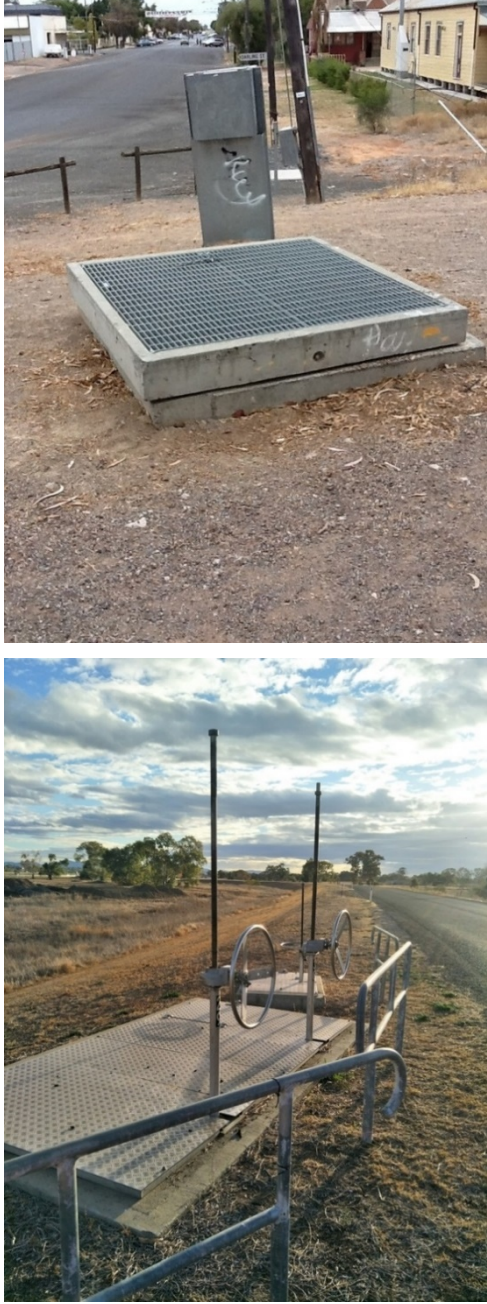
±	<p><b>Marginal</b></p> <p>Entry / exit to the confined space unlocked.</p> <p>Operators' training and safe entry equipment outdated or not adequately available.</p>	Insert Photo	Cannot enter into the confined space for O&M. Potential fatalities if accessed by the public.	←	---	<p>Lock entry / exit points immediately. Update training course and obtain new entry equipment immediately.</p> <p>When locked and training / equipment updated:</p> <ul style="list-style-type: none"> <li>Operational (annual) Inspection as a minimum;</li> <li>Pre-Flood Inspections;</li> <li>Visual Audits.</li> </ul>	Unreliable (moderate risk of fatalities)

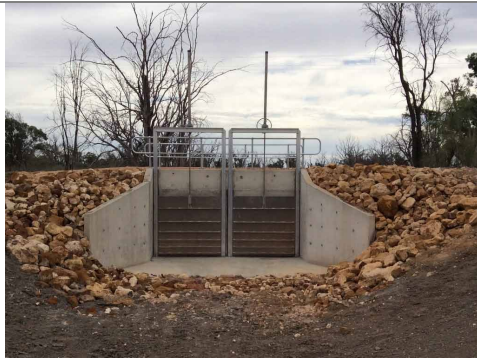
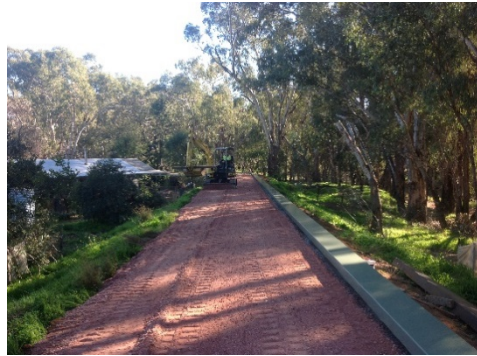
✔	<p><b>Acceptable</b></p> <p>No dangerous protrusion of any items (permanent or damaged levee features).</p> <p>Protection provided for protruding items that cannot be eliminated.</p> <p>Top example photo: Floodgate's rising spindle protected with cover tube.</p> <p>Bottom example photo: Sheet pile crest protected with appropriate capping.</p>
