PART 3: LANDSCAPE MANAGEMENT PLAN

Apple Tree Bay is a popular recreational destination within the Ku-ring-gai Chase National Park. Prior to the reclamation of the swimming baths (tidal flats between 1937 and 1958), Apple Tree Bay provided an overflow area from Bobbin Head.

This Landscape Management Plan provides a comprehensive assessment of the existing park conditions and identifies key opportunities and constraints with respect to park planning and management, leading to principles and actions directing the future development and management of the landscape. The Conservation Management Plan and the Landscape Management Plan, along with specialist reports contained in the Appendices, inform the Masterplan for Apple Tree Bay.

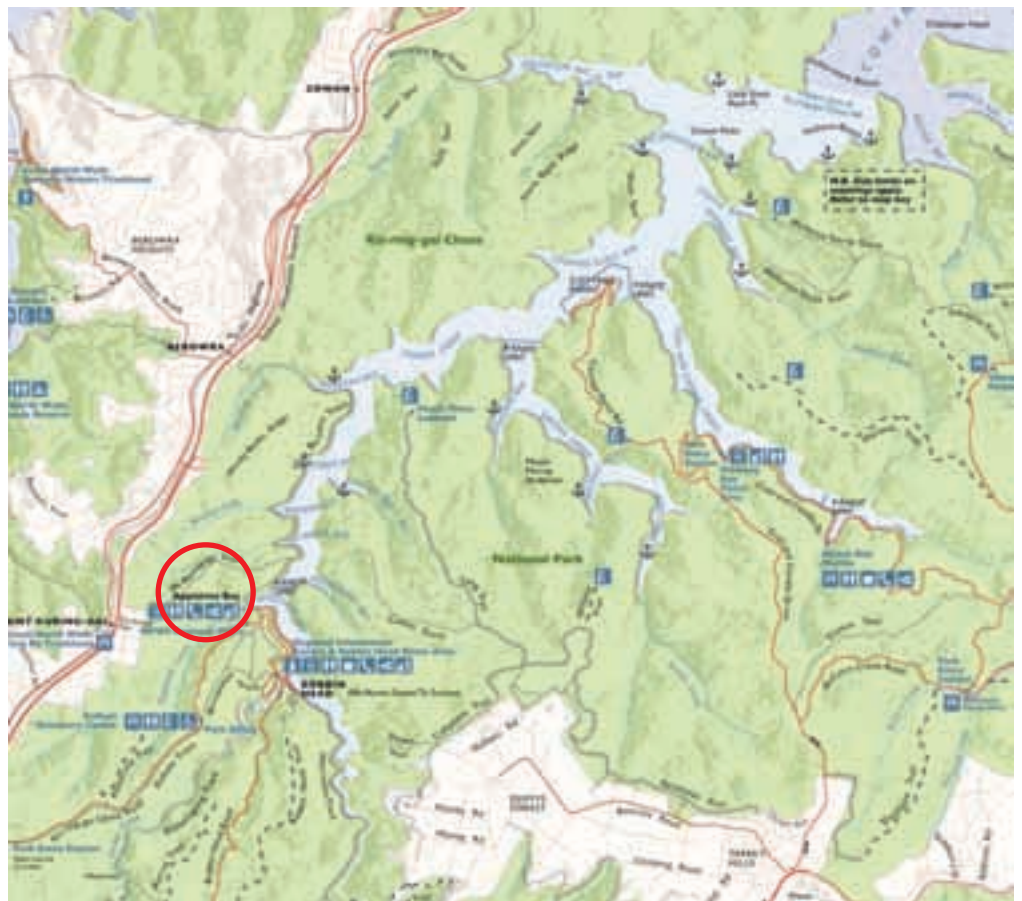
Figure 1.1: Location of Apple Tree Bay, Ku-ring-gai Chase National Park (Source: Department of Environment and Conservation)

The subject area of Apple Tree Bay is located within Cowan Creek, which adjoins the Hawkesbury River at Broken Bay. Apple Tree Bay is formed by the junction of Apple Tree Creek with Cowan Creek and is located on the western side of Cowan Creek. The study area comprises the reclaimed land located on the southern side of Apple Tree Bay (Refer to Figure 1.1).

Refer to Figure 1.1

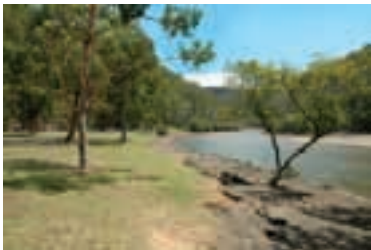
Apple Tree Bay is formed on an in-filled estuarine bay. Investigations have indicated that the fill is of possible local Hawkesbury sandstone origin and very stony and compacted. The surface soils are also compact and impermeable to water, causing surface water to run off quickly, thereby allowing little water infiltration.

P8. Existing soil conditions.
(source: CM*)

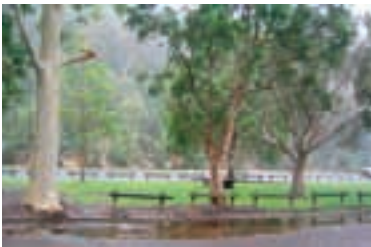
Overland flow within the park generally flows away from the natural edges of the site towards the foreshore areas. Some ponding occurs in the car park, due to insufficient cross falls. Overland flow also occurs from the natural slopes on the periphery of the park into the park. The park's reticulated stormwater system collects run-off from the asphalt roads and car parks and deposits the untreated water directly into Apple Tree Creek and Apple Tree Bay. Due to the impermeable surface layers of soil, the reticulated stormwater system effectively has a greater stormwater load to manage. Petrochemicals and other pollutants are not treated prior to entering Apple Tree Bay.

P9. Ponding in carpark. (source: CM*)

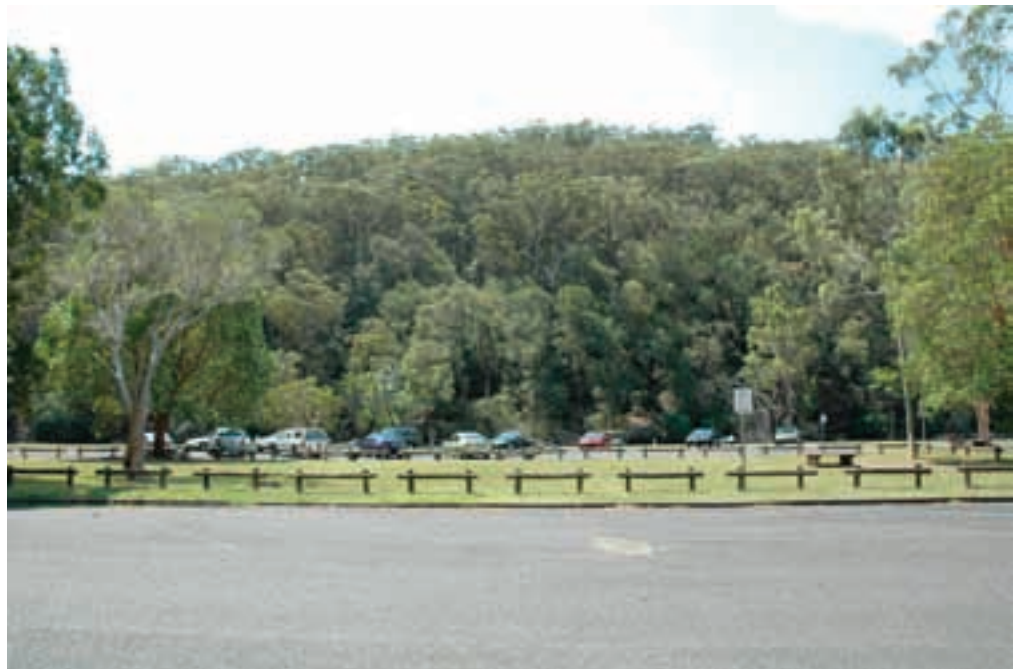
P10. Extensive reflective surfacing and minimal shade reduces visitor comfort on warmer days (source: CM)*

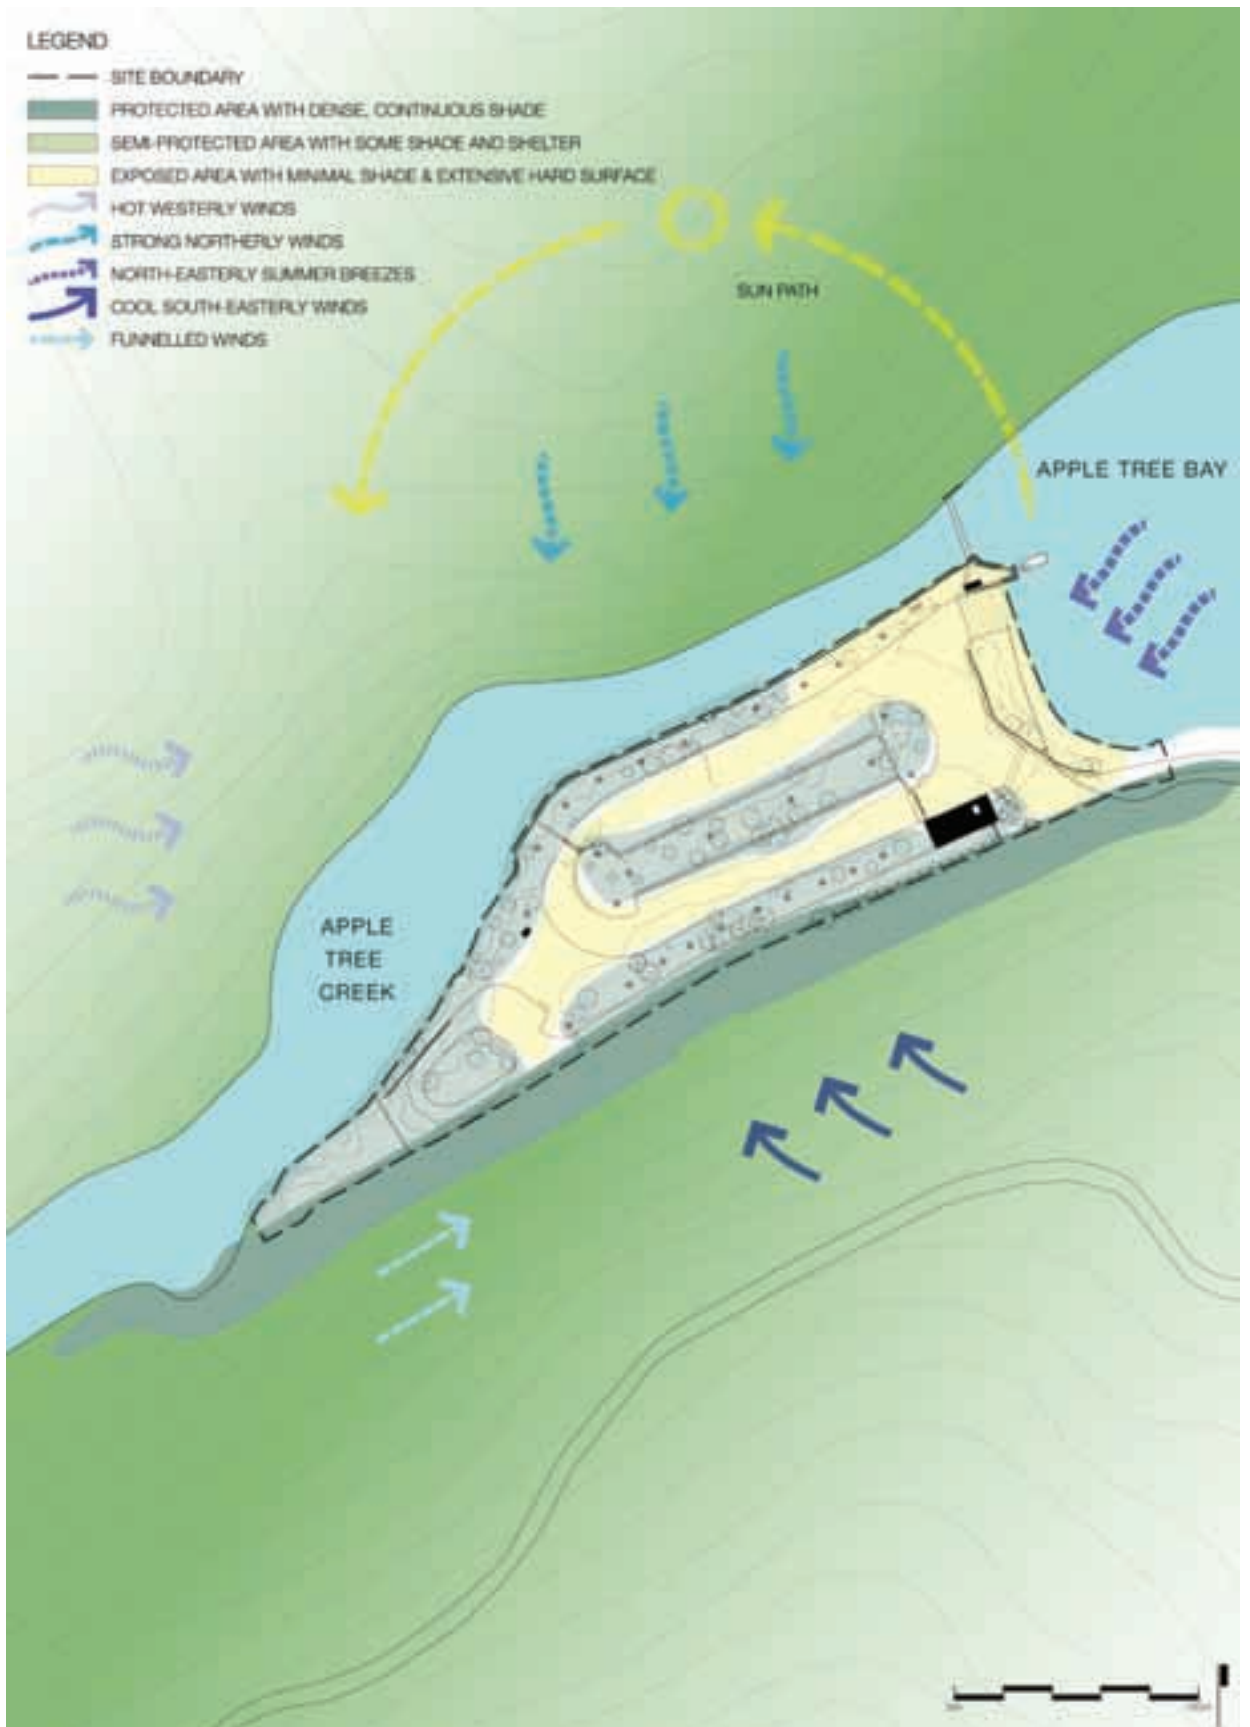
Figure 4.2: Existing Microclimate

The majority of the park is an open, exposed environment with relatively little shelter or shade. The lack of protection from the sun in summer is compounded by the large expanses of heat-reflecting bituminised surfacing of road and car parking network. The steep slopes and vegetation to the rear of the park provide little shade relief within the park environment, due to their northerly aspect.

The location of the park within the valley, however, causes it to be relatively protected from strong winds.

Refer to Figure 4.2.

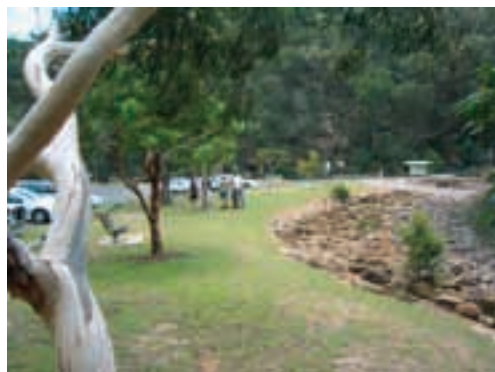
P11. Stunted tree growth is likely to be caused by compacted soils and nutrient deficiencies. (source: CIM*)

Soil compaction, nutrient deficiencies and soil salinity are likely to be causing death and poor performance of both trees and turf. Additionally, a lack of attention to trees in their early stages is evident in trees on the park and has resulted in a backlog of pruning tasks such as removal of weak branching, multiple leaders, overly dense canopies and trunk and branch fungal decay.

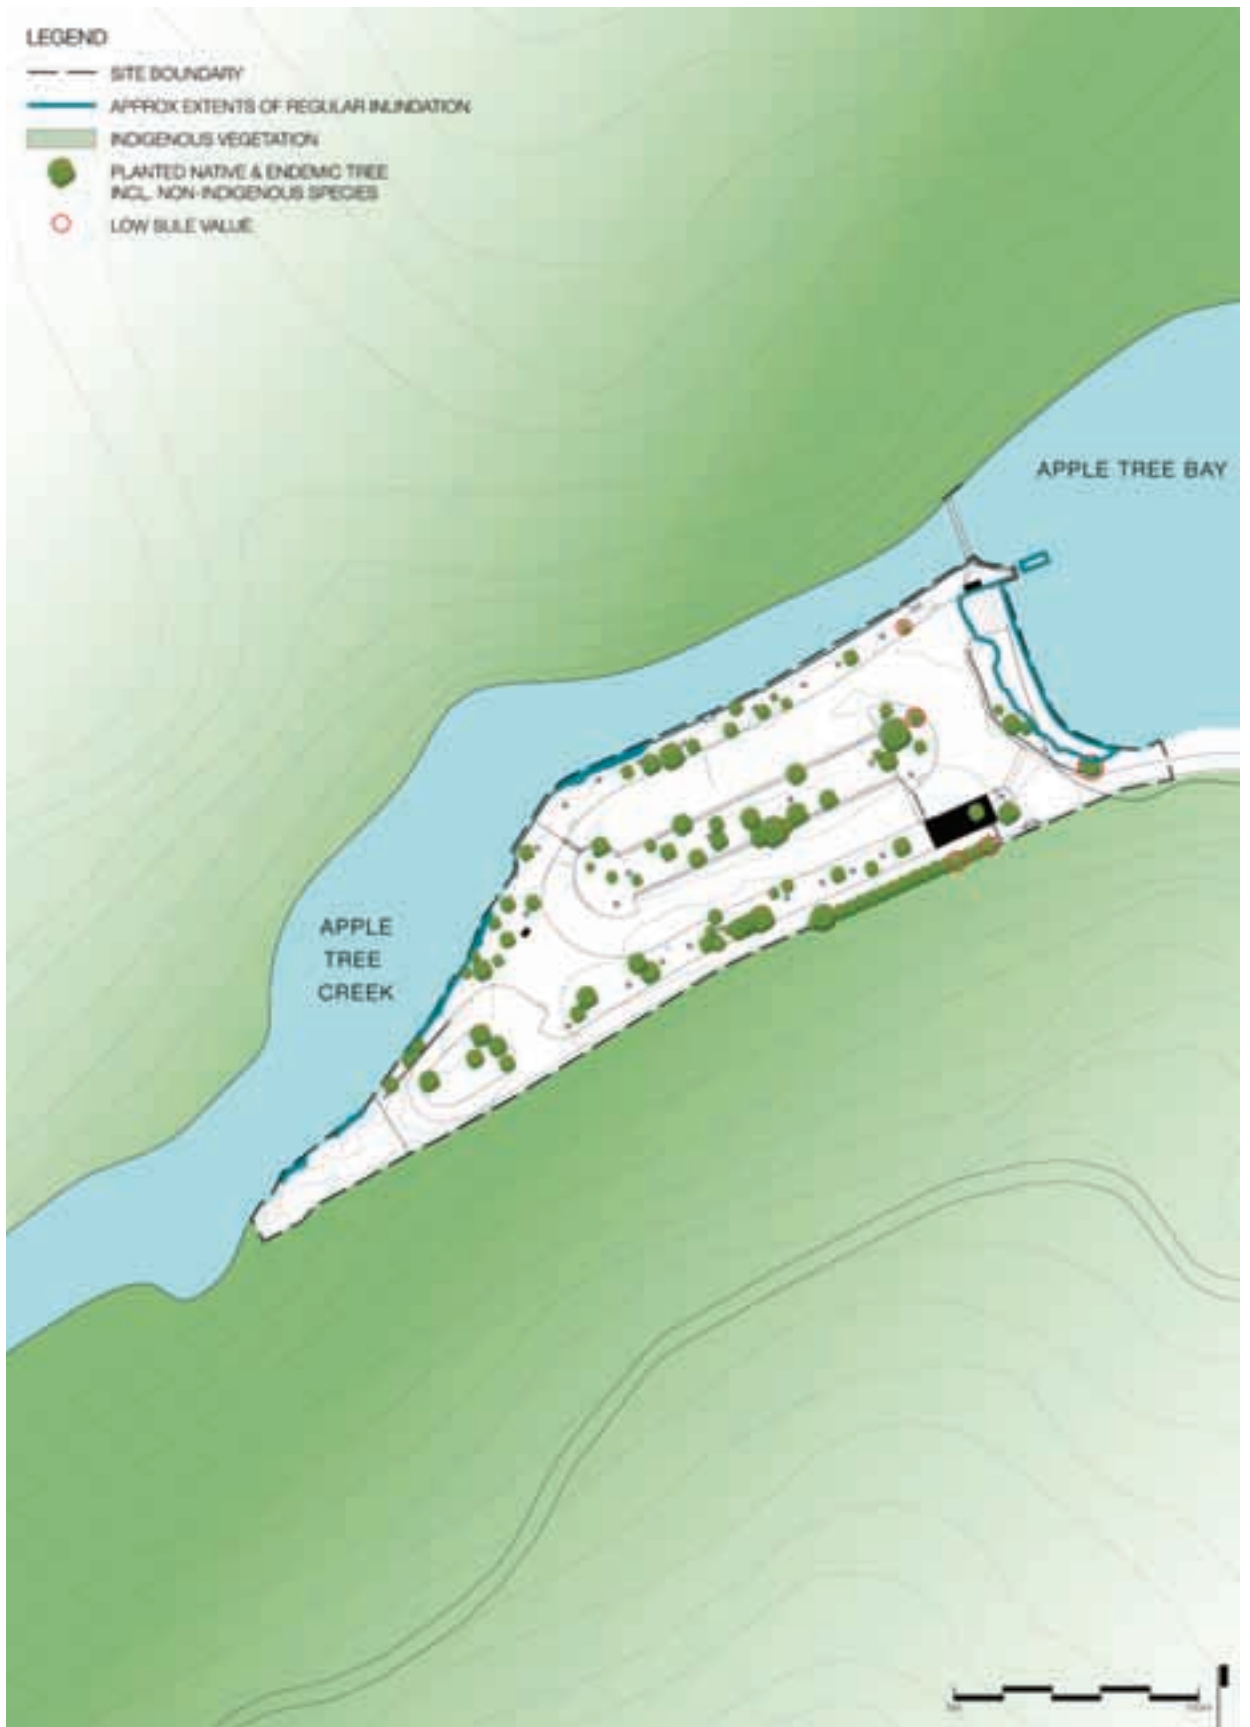
Figure 4.3: Existing Vegetation

At Apple Tree Bay, naturally occurring endemic vegetation occurs on the steep slopes at the periphery of the park and conforms to *Angophora costata* - *Eucalyptus piperata* open forest and woodland communities. Vegetation in this community is generally weed free and in good condition, however, some trampling is evident, particularly in areas which are easily accessed. Patches of mangroves occur in disturbed soils along the western part of the park and along the edge of Apple Tree Creek, and are likely to be regrowth.

Refer to Figure 4.3

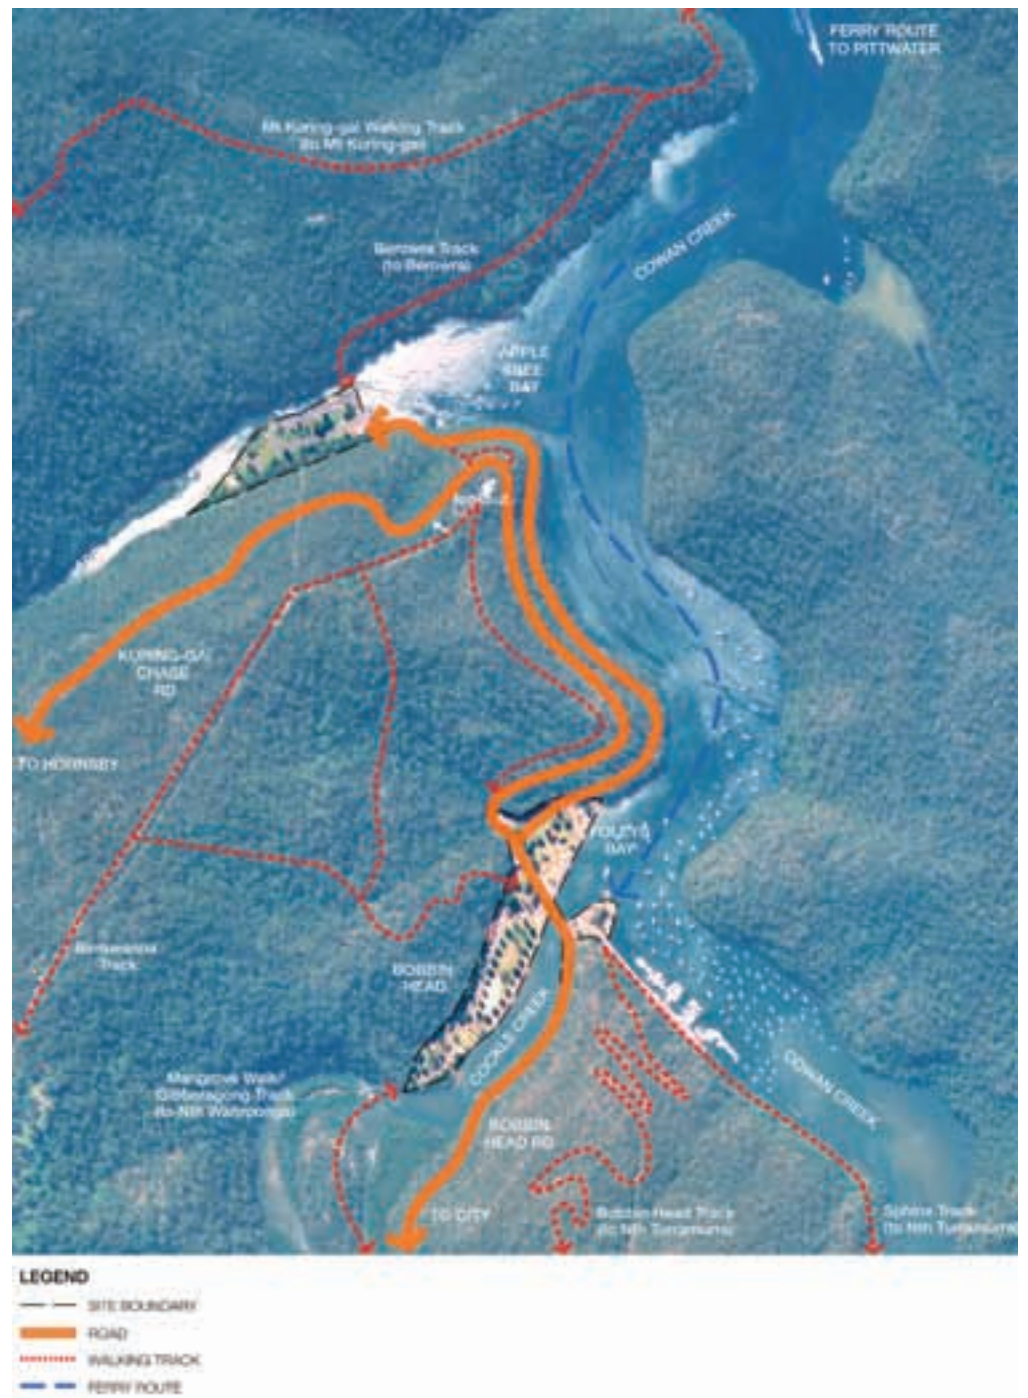
Figure 4.5: Park Access

Most visitors to Apple Tree Bay arrive by car or boat. No public transport services reach the parklands. Walking to Apple Tree Bay from areas outside the park is possible, however, the distance and steep grade discourage most walkers.

Refer to Figure 4.5. Refer to Volume 3, Appendix 1.3; Traffic and Transport Planning Report.

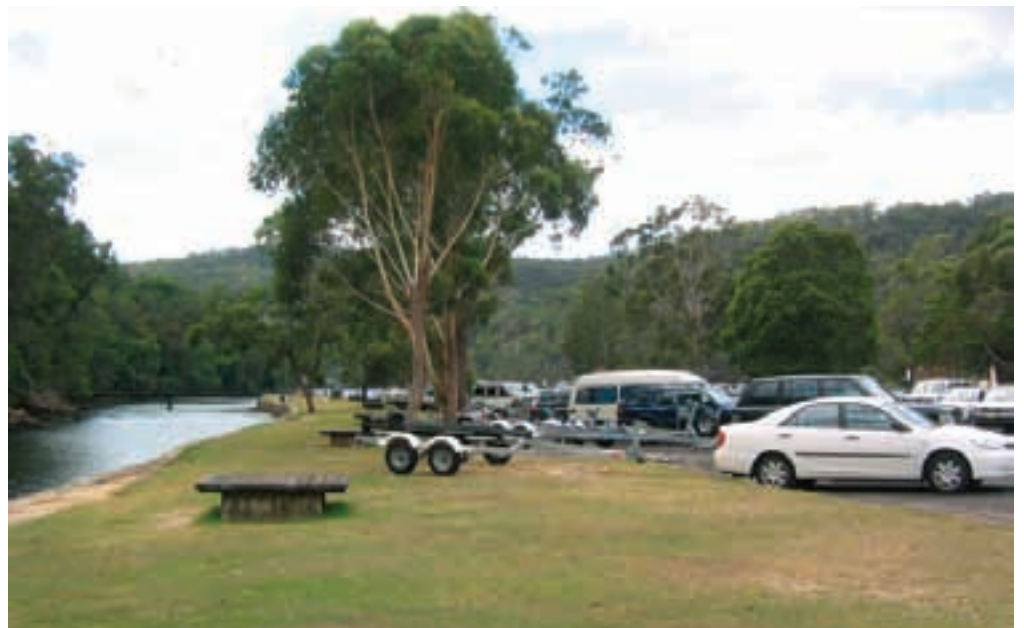
P23. Vehicles with trailers regularly mount kerbs, causing soil compaction and resulting in grass wear and diminished tree growth. (source: CM⁺)

- There is inadequate definition between car parking and car-with-trailer parking.
- Cars with trailers frequently back onto grassed areas, causing compaction and grass wear.
- There is a lack of drop-off points and 5 minute standing.
- There are conflicts between pedestrians and vehicles launching boats, adjacent to the boat launching ramp.
- There is a lack of accessibility to many facilities for disabled people and pram-users.
- There is a lack of information, maps and signage to amenities, increasing visitor disorientation.
- Speeding occurs on the access road to Apple Tree Bay.
- Pedestrian access from Apple Tree Bay to Bobbin Head is currently only possible by road or via a Grade 3 or 4 ridge track, which requires strenuous exertion.
- Coaches are unable to negotiate hair-pin turns on Apple Tree Bay Road.
- Cyclist and vehicle conflicts on Apple Tree Bay Road require consideration.

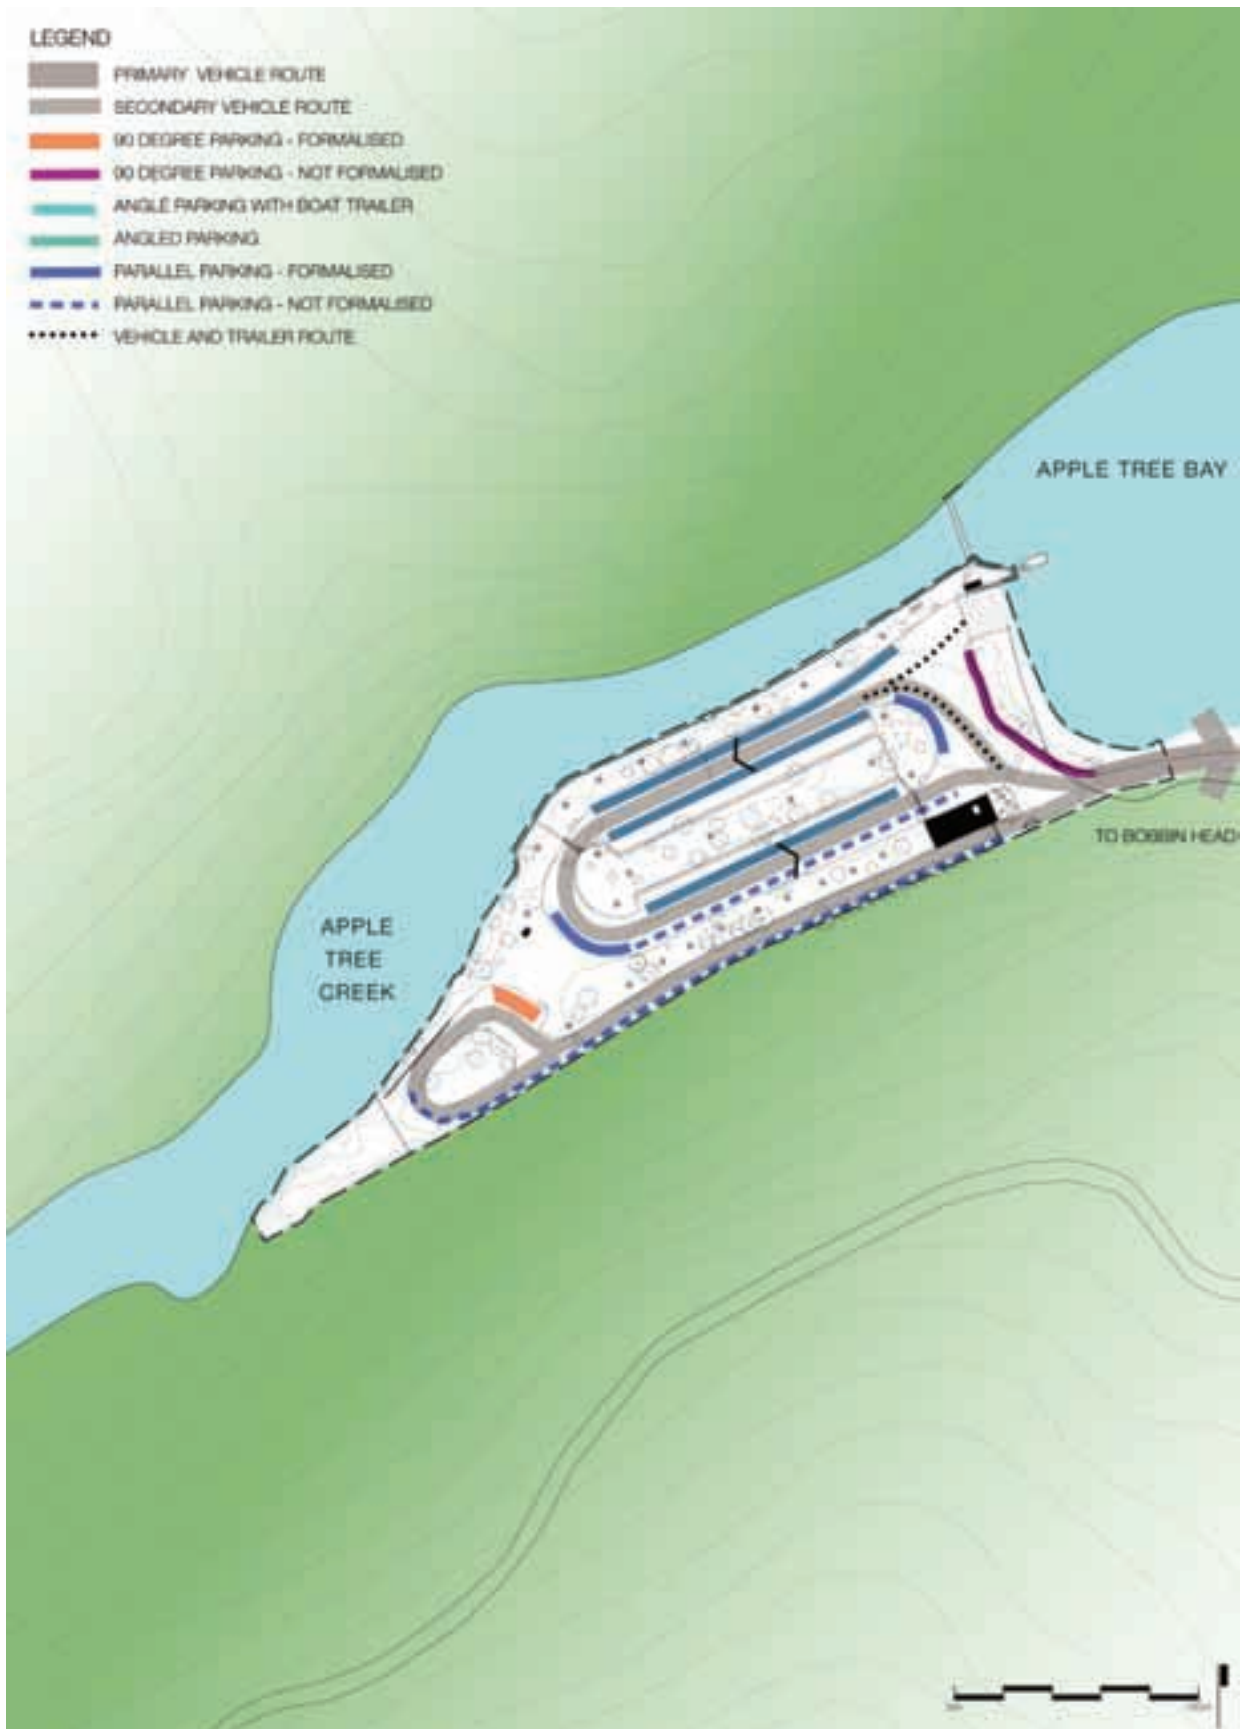
Figure 4.6: Existing Vehicular Circulation and Parking

Car parking is dispersed over the entire park, dominating the park setting. The popularity of the park for boat launching causes car parking spaces to fill up quickly on weekends. Poor definition of car parking bays causes cars with trailers to regularly park in spaces assigned for cars only, while the reverse also occurs. Cars with trailers often mount the kerb, compacting topsoils and reducing the amenity of recreational areas, generally.

- Formal car parking: 45
- Formal trailer lot: 82
- Disabled trailer lot: 2
- TOTAL existing car parking capacity: 129

Refer to Figure 4.6.

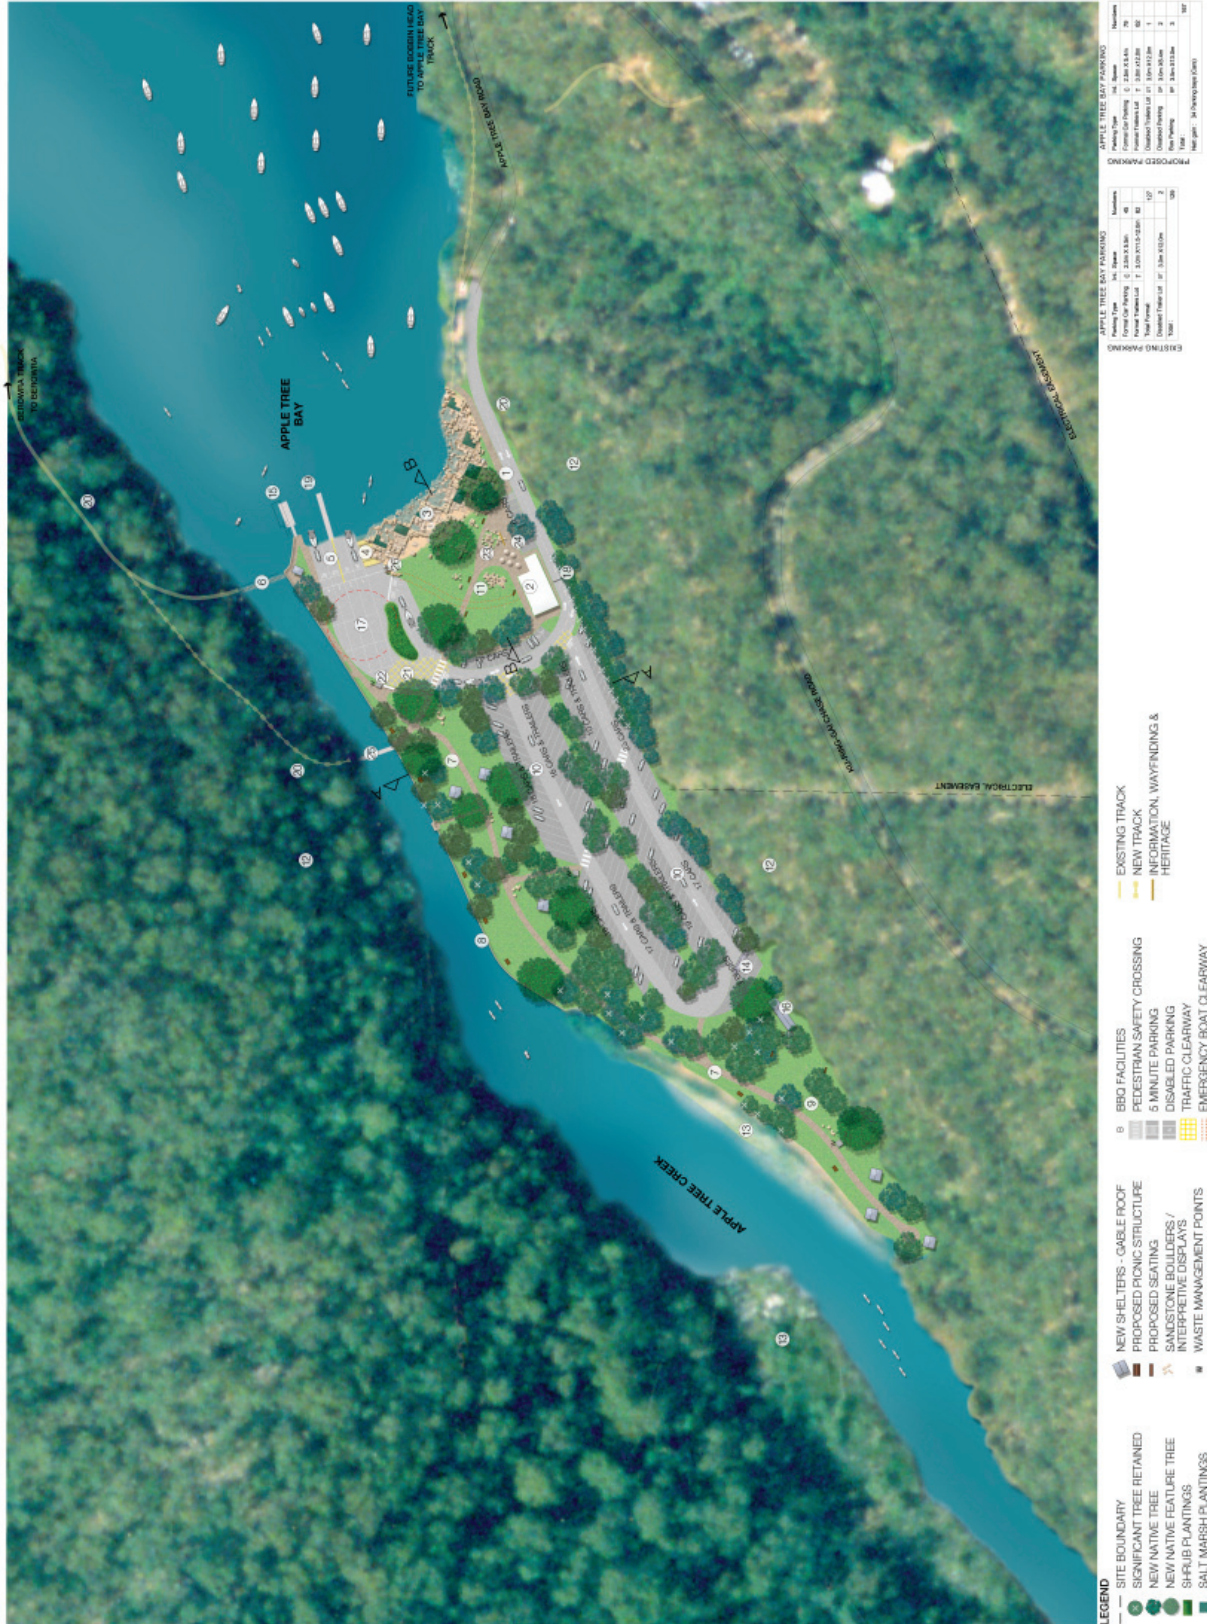
Figure 7.1. Landscape Masterplan for Apple Tree Bay

- 18 RELOCATE SERVICES UNDERGROUND
 - 19 PROPOSED PAVEMENT TO ASSIST WITH BOAT INTERPRET & CONSERVE ABORIGINAL ARTIFACTS / ARCHAEOLOGICAL SITES
 - 20 BOAT & TRAILER WASH DOWN AREA

- 21 FISH CLEANING AREA
 - 22 OUTSIDE SEATING AREA
 - 23 SERVICE YARD
 - 24 PROPOSED NEW LOCATION FOR RELOCATED FOOTBRIDGE
 - 25 CANOE STAND

New tree planting is proposed to be entirely selected from endemic species of local provenance to integrate the parklands with the surrounding bushland. Tree selection will be based on species with good shade provision and which are tolerant to park conditions (including salinity) and not invasive to bushland. A suggested planting list is provided in Figure 7.1.

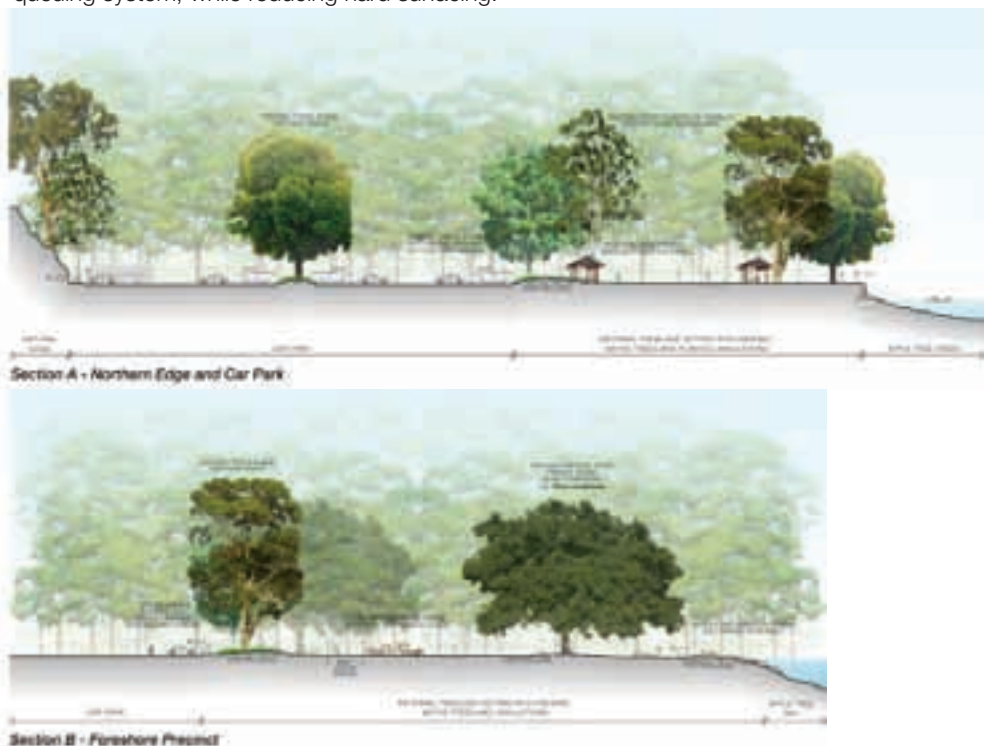
Figure 7.2. Landscape Sections for Apple Tree Bay

The parklands of Apple Tree Bay will be transformed to a shady naturalistic landscape that melds with its natural setting and provides improved recreational and educational opportunities for visitors. The design of the parklands rebalances the needs of recreational users, including picnicking, walking and boating. The realisation of this Vision requires the relocation and reconfiguration of the car park to the rear of the park, opening up a broader area of parkland along the northern and eastern waterfronts.

New picnic facilities, including shelters, barbecues, benches and tables, are proposed to be implemented throughout the park, particularly along the northern waterfront zone. The eastern water frontage to Apple Tree Bay will be converted to a series of tidal rock pools constructed from large sandstone boulders and the adjacent existing building converted to a kiosk / café taking advantage of the views to the Bay. The boat launch facilities will be upgraded with a new road configuration and traffic management systems, which will improve the efficiency of the traffic queuing system, while reducing hard surfacing.

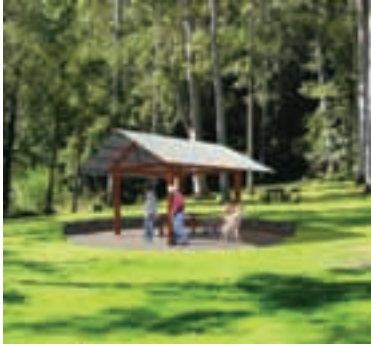
Currently, there are limited picnic facilities in the park, indicating that the main use of the park is as a boat launch location. The Recreational Planning seeks to encourage greater use of the precinct for picnicking and other park-based activities. New picnic facilities proposed include shelters, barbeques, benches and tables throughout the parkland, particularly along the northern waterfront zone. The shelters and other facilities will have a contemporary character and be coordinated with the design of other infrastructure and facilities in the park, utilising similar materials, forms and finishes. A group shelter with barbeque facilities is proposed in the western portion of the park, adjacent to bus parking. Occasional clusters of sandstone boulders placed throughout the parklands will also provide seating and picnicking surfaces and will enhance the sense of being in the natural environment. Waste disposal facilities, including recycling facilities, will be provided near to picnicking facilities and will be visually downplayed by sensitive detailed design.

P30. New shelters and picnic facilities (source: CM*)

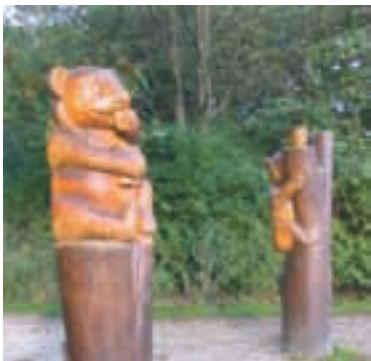
A new interpretation area incorporating sculptural and interpretive elements is proposed adjacent to the kiosk building. Tree planting will provide shade. Seating and drinking fountains will be installed. It is intended that the design of the foreshore area will visually integrate with its setting and be aesthetically pleasing.

P32. Interpretive Elements (source: unknown)
