GOAT ISLAND

Conservation Management Plan

Volume 4

Appendices

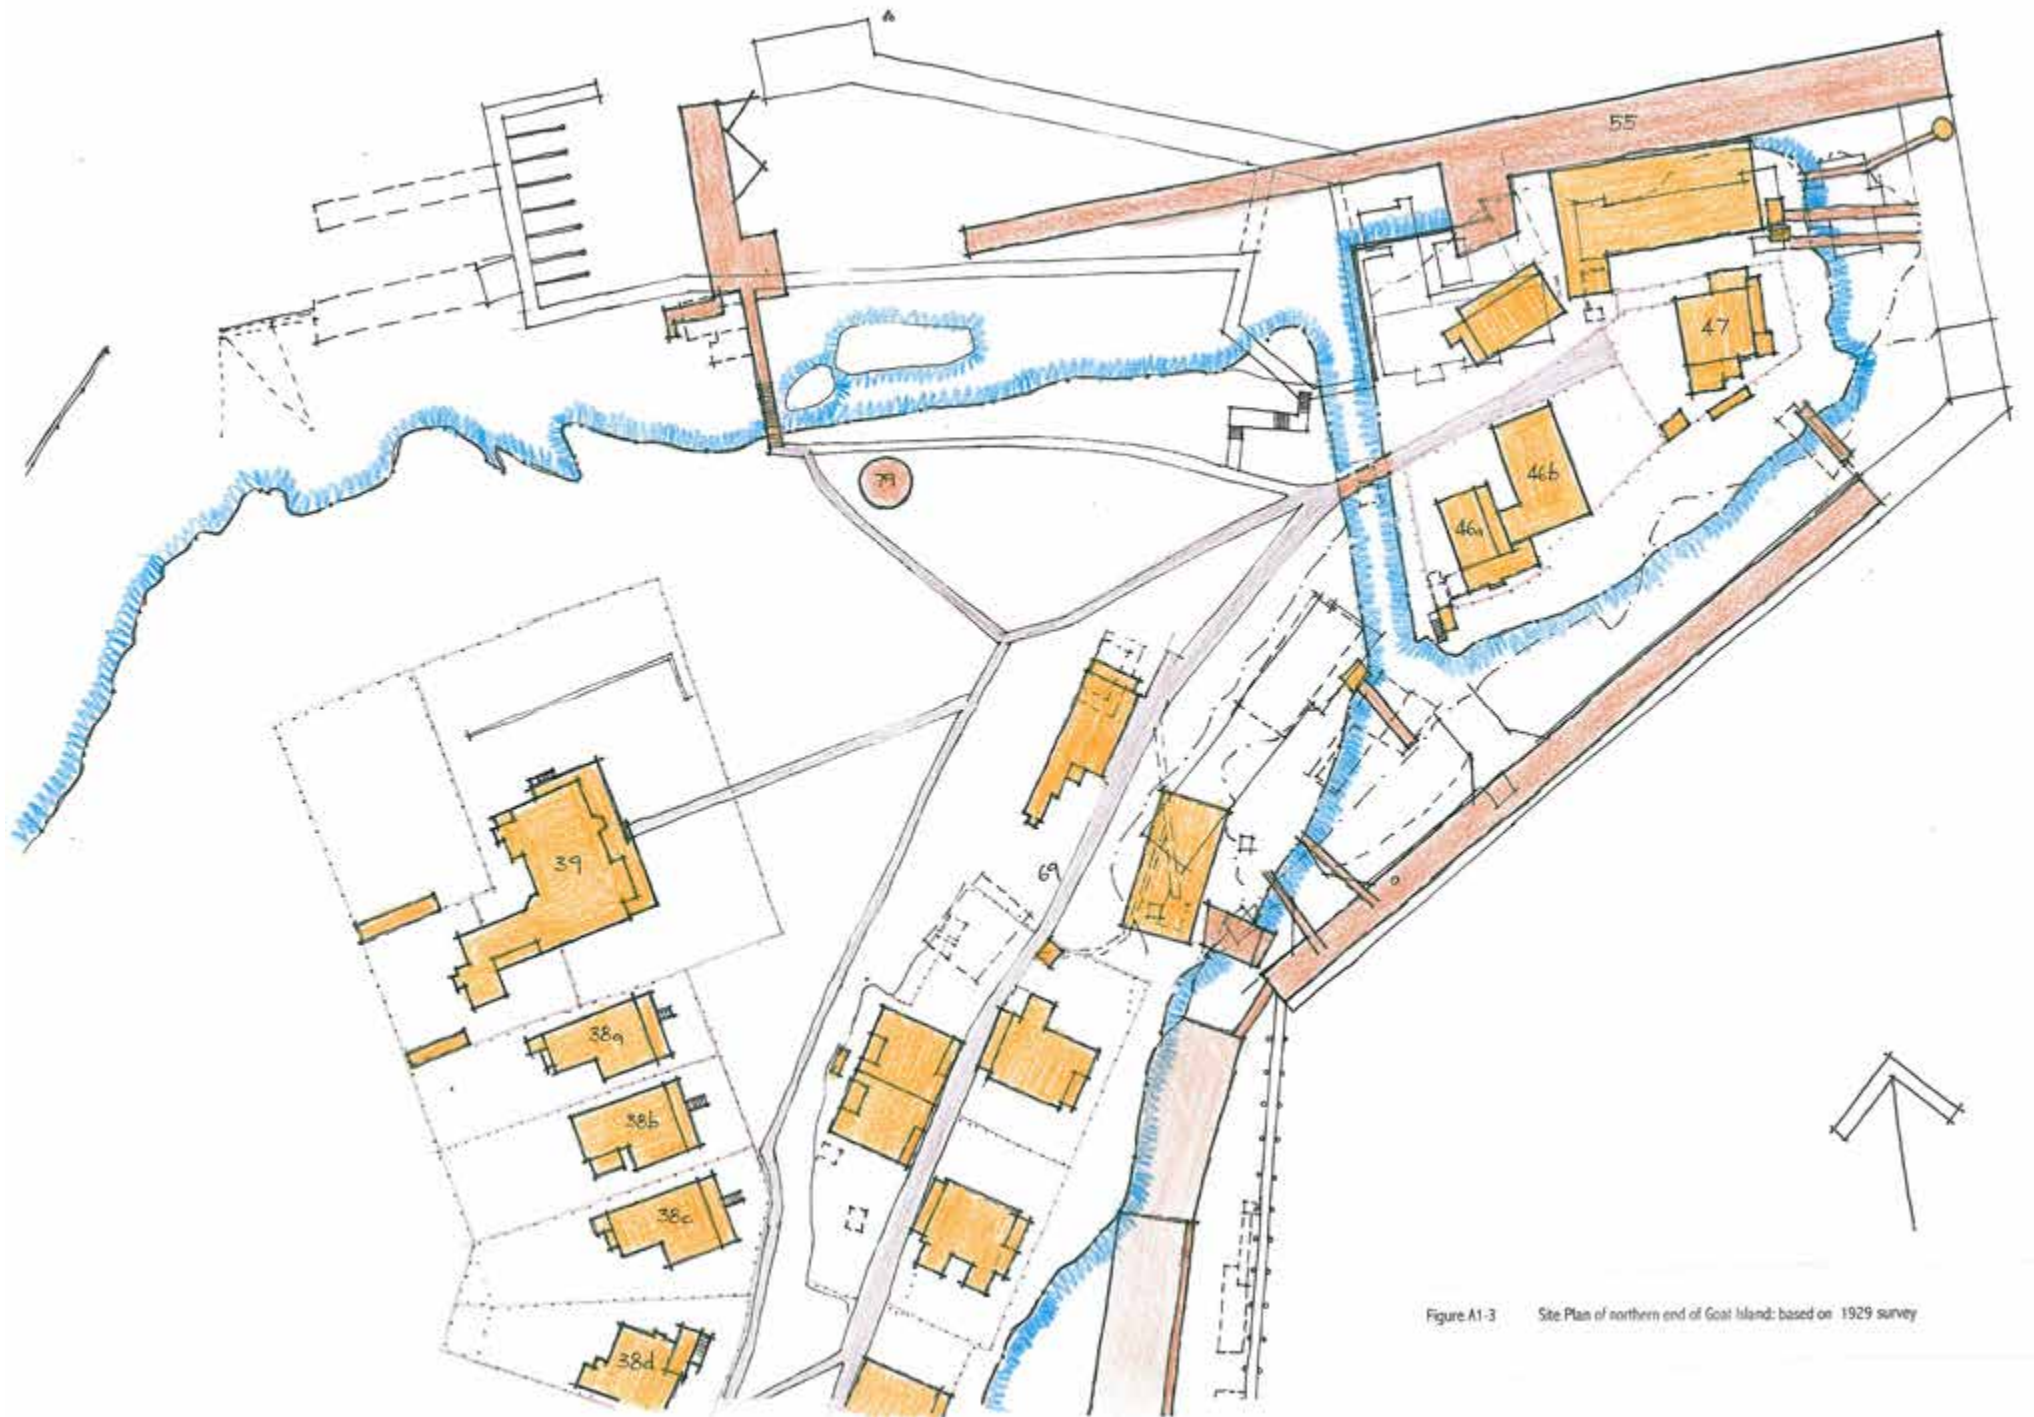
Figure A1-3 Site Plan of northern end of Goat Island: based on 1929 survey

The extant buildings at the plan dates are shown in orange, with extant wharves in brown. Extant shorelines at the plan dates are shown in blue.

These plans are provided to demonstrate the layering of the site, the location of earlier site elements in relation to the current structures, site features and landforms and to illustrate how the edges of the island and the shoreline development have evolved.

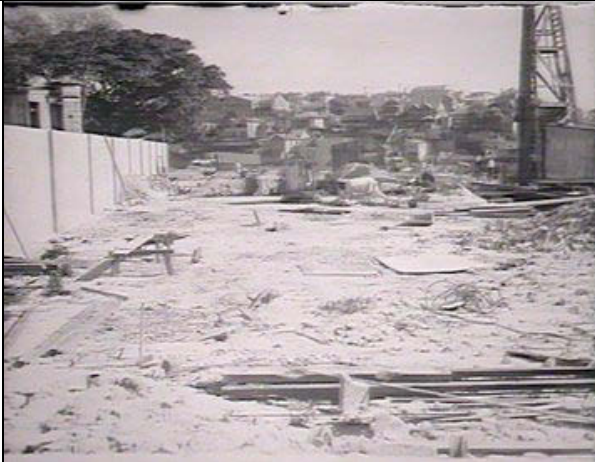
State Library	d1_10116. 1946 photo of construction site of the Ship Repair Workshop on Goat Island

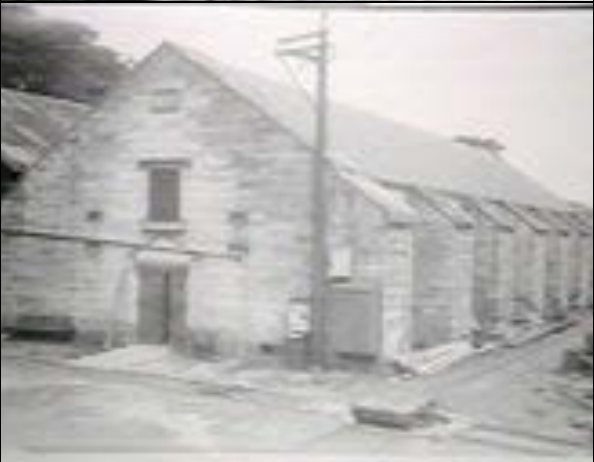
LIBRARY/ ARCHIVE	IMAGE DETAILS	IMAGE
State Library	d1_10037/ GPO 1 – 10037. 1923 image of Queen's Magazine south elevation and south elevation of Cooperage, single storey explosives magazine (1885?) built against the fortified wall.

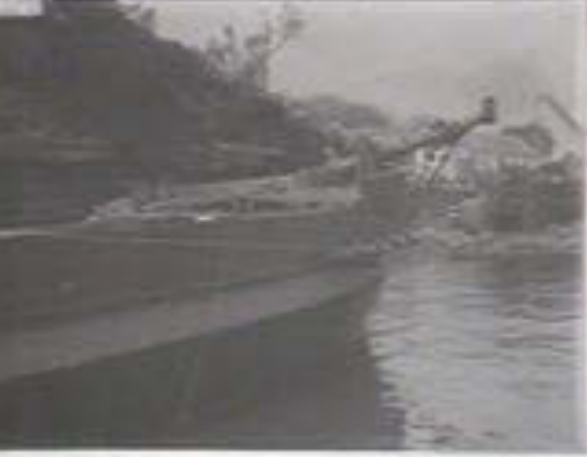
State Library	d1_10263/ GPO 1 – 10263 Replica "Supply" under construction at Goat Island shipyard, August 1937

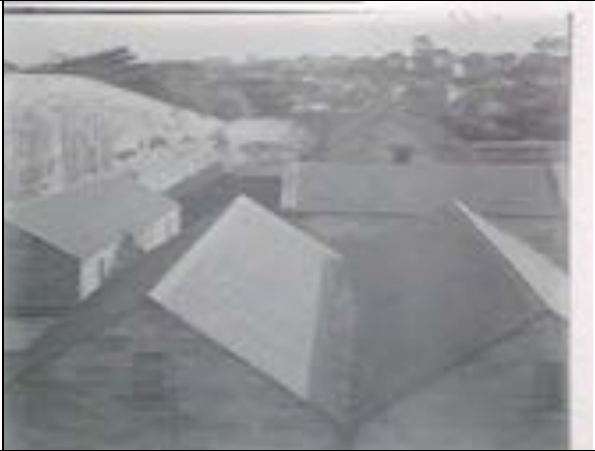
LIBRARY/ ARCHIVE	IMAGE DETAILS	IMAGE
State Library	d1_13442. 1918 photo showing Colonial Magazine in foreground, 2 nd cooperage (aka Stores Building) to left, 1 st cooperage and Queen's Magazine behind

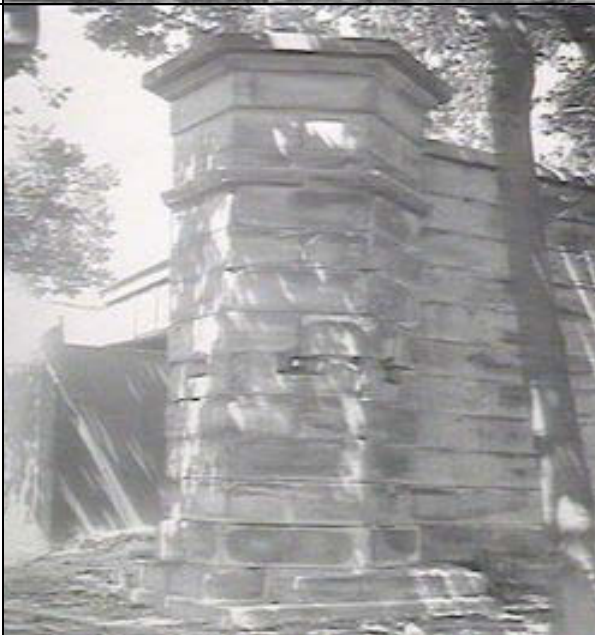
LIBRARY/ ARCHIVE	IMAGE DETAILS	IMAGE
State Library	d1_10047. 1940 photo of gate in Fortified Wall showing original timber entry gates.

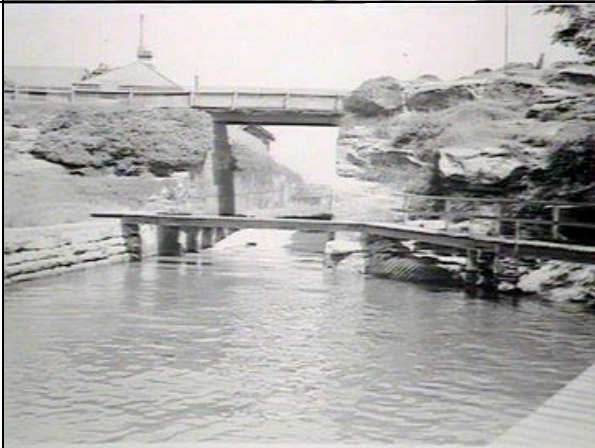
LIBRARY/ ARCHIVE	IMAGE DETAILS	IMAGE
State Library	d1_10050. 1953 photo of Goat Island slipways

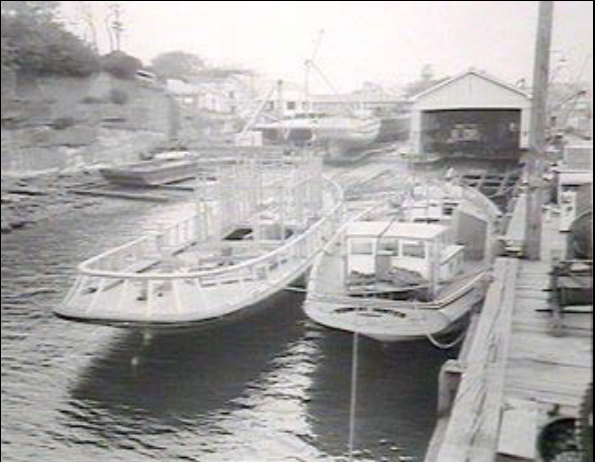
State Library	d1_10058. 1966 photo of Goat Island slipways with Hammerhead Crane

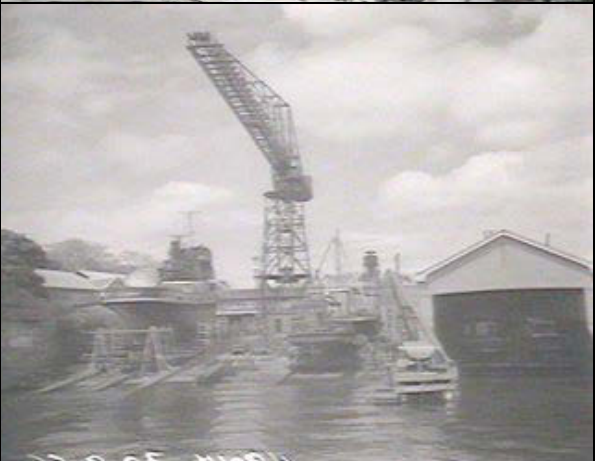
State Library	d1_20851. 1928 photo of Goat Island slipways

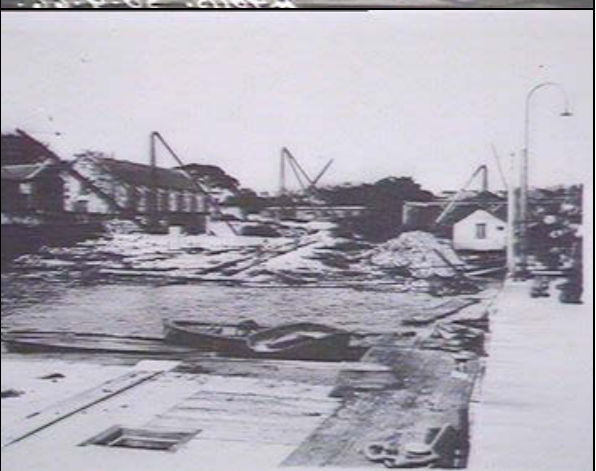
LIBRARY/ ARCHIVE	IMAGE DETAILS	IMAGE
State Library	d1_25000. 1956 photo of Goat Island slipways

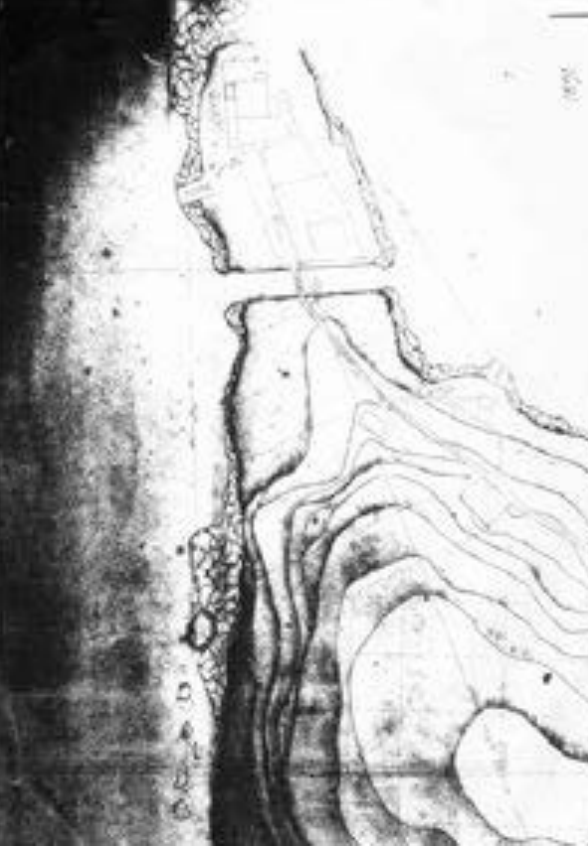
Lands Dept	<p>An informative 1924 plan of the island showing the extent of the Harbour Trust development just prior to their redevelopment of the magazine precinct. The Trust added the various residences on the ridge and to the east, the fire brigade barracks, workshops and stores along the northern shore and converted the barracks and kitchen and used the water police building for residential use. Many of the buildings built in this phase have been removed including the workshop and stores buildings and six of the residences.</p> <p>The wharves at this time comprise: the early stone jetties and wharves to the magazine precinct, an area of fill near the magazine in preparation for the new wharf construction, the first north wharf and ferry jetty, located with a parallel outer face, the stairs and jetty for the Harbour Master, the rough eastern wharf located off the shore line and several skeleton wharves further south braced off the cliff face. The only wharf elements remaining from this period are the stair to the residences and the alignment of the north wharf however both elements have been rebuilt.</p> <p>This plan also shows the privy (94) and the small stores building (109) located near the barracks.</p>

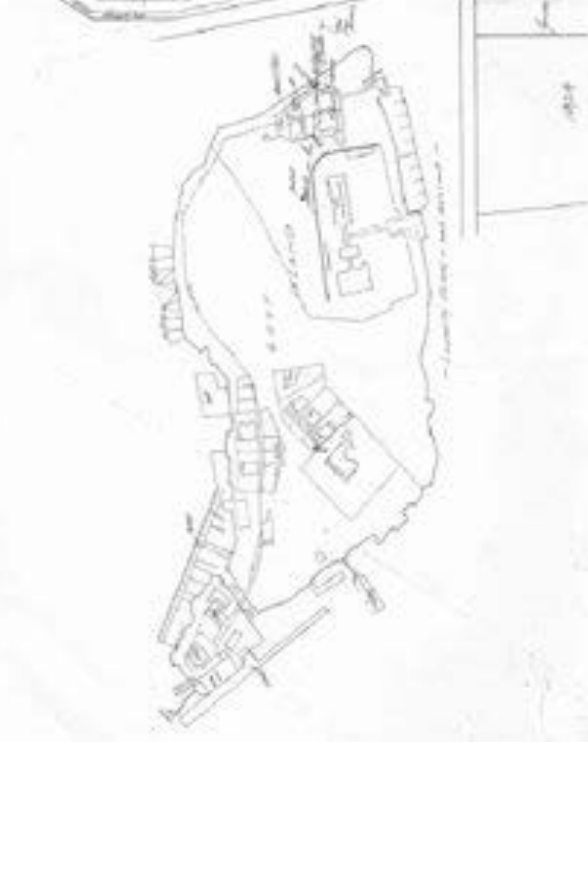
LIBRARY/ ARCHIVE	IMAGE DETAILS	IMAGE
Lands Dept	<p>A detailed plan from 1929 (part of plan of whole island), nearing the end of the Harbour Trusts tenure of northern area of the island showing more detail of the layout of the buildings and wharves. It is interesting to observe the range of small buildings, sheds, boatsheds and ramps around the edge of the water, the full length of the cut that was modified around 1960, the fence line of the Harbour Master's residence and what appears to be the incorporation of one of the magazine buildings from 1875 into the residence visible in the centre of the drawing.</p> <p>The stone seawall immediately to the north of the cut returning to the east appears to date from around 1901 and also appears to remain intact as the face of the current wharfage.</p>

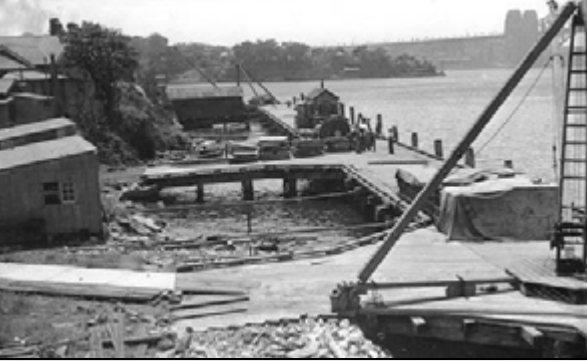
SLNSW GPO1-10051.	<p>"Samson" Coaling. 9.1.1952.</p> <p>This is the clearest illustration of the coal platform that has now been removed. Also note the dolphins that were replaced when the new slipway was constructed.</p>

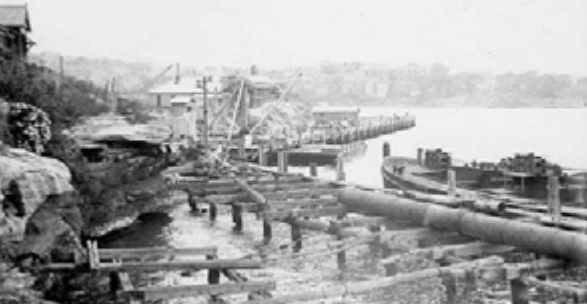
SLNSW GPO1-19371.	<p>Wharf construction c1940. This picture has been attributed to the 1920 period but the ferry wharf was not angled until reconstruction in c1945. The pool area is visible to the left of the frame. The shed to the west of the pool seems to have been moveable – it appears in a number of locations in various photographs as construction works are carried out. This also shows the wharf at approximately half its current length suggesting that the photo was taken during construction. There is no documentary evidence that this wharf was built in stages.</p>

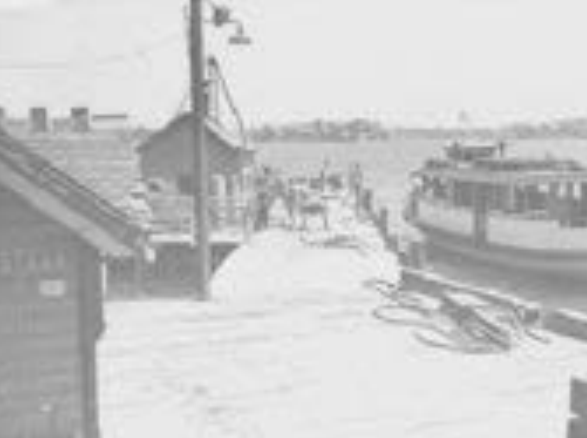
SLNSW GPO 1-07969	<p>Construction of the ferry wharf. Undated Most likely 1944 after the addition to the end of the wharf was complete.</p>
