# Timber repairs

## Wood and water

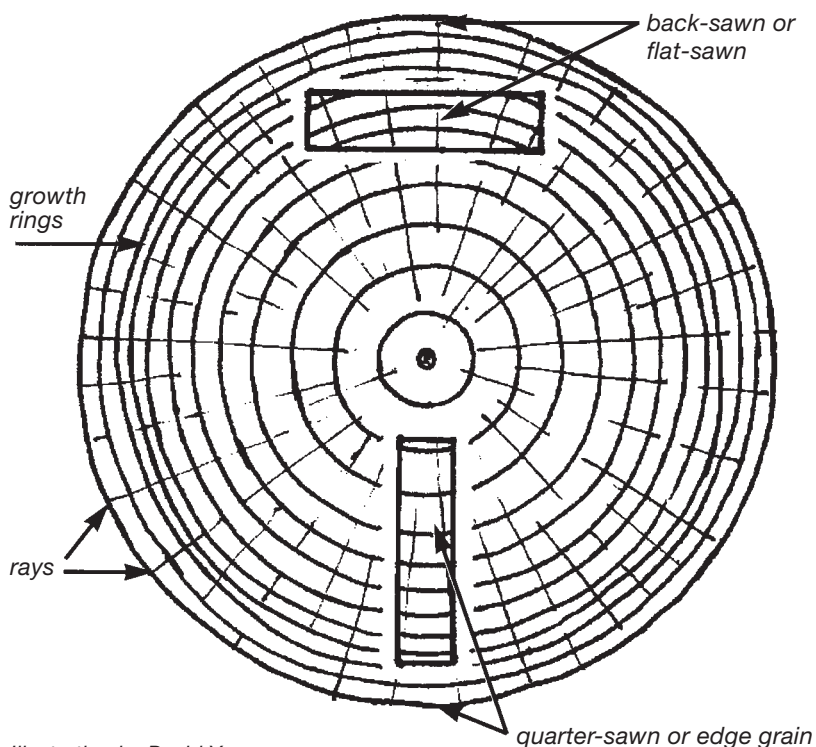
### **Back-sawn and quarter-sawn timber**

*Back-sawn timber (tangentially cut) will swell and shrink in response to changes in moisture levels to a much greater degree than the radially cut, quarter-sawn timber.*

Most swell or shrinkage occurs tangentially (around the circumference of the log), where it can be up to 12% of the original size, compared to up to 6% radially. The amount of swell or shrinkage also varies between

species and with different growth conditions. Boards cut tangentially (back-sawn or flat-sawn) will swell in width up to twice as much as boards cut radially (quarter-sawn) and are less suitable for use in exposed locations such as weatherboards. Fortunately, wood swells very little longitudinally (0.1%-0.2%), or it would have to be specially treated to be used for building or furniture.

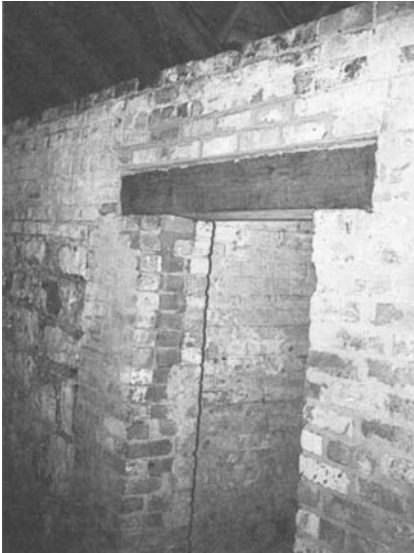
*This replacement lintel was green (unseasoned) when installed as part of repair works. It has now dried and shrunk, leaving a 20mm gap and unsupported brickwork above.*

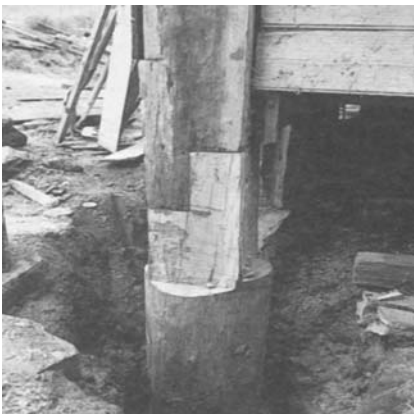
*Replacing the rotten base of a post while retaining as much of the original as possible. Note the light outer sapwood and the darker heartwood of the new post base. The use of fungicidal rods and external 'bandages' should be considered when undertaking work such as this, particularly as the sapwood has no inherent durability. Posts not carrying a heavy structural load should not be set in concrete, but in free-draining gravel and earth.*

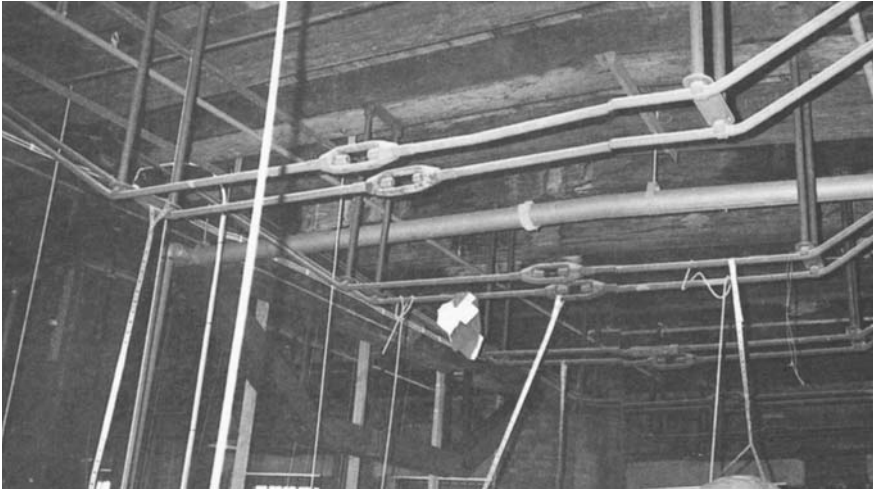
*Trussed girders used to strengthen beams at Walsh Bay wharves, Sydney.*

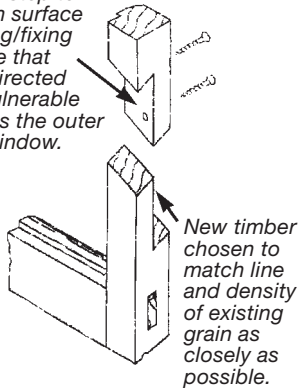
#### (i) Patching the bottom rail

Splayed splice joint with undercut and step to give optimum surface area for gluing/fixing and to ensure that moisture is directed away from vulnerable areas towards the outer face of the window.

Doors and windows typically suffer from rot at the base of the frame and door leaf or window sash, and also from loosening of joints. After any necessary patching of pieces which are beyond repair, the joints should be made tight by replacing wedges and regluing. On window sashes, minor decay combined with loose joints can often be repaired by removing the decay and repairing with epoxy, and using brass angle brackets let into the surface on the inner face.

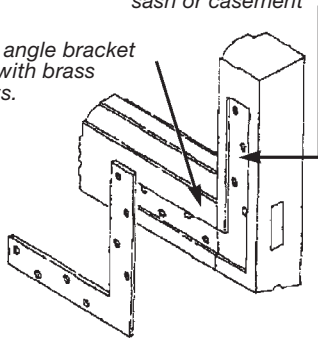
#### (ii) Reinforcing a loose corner with a brass angle

Bracket let into (or fixed on surface of) timber on inner face of sash or casement

Brass angle bracket fixed with brass screws.
