CARTWRIGHT'S HILL SUBDIVISION

City of Wagga Wagga

Landscape Stability

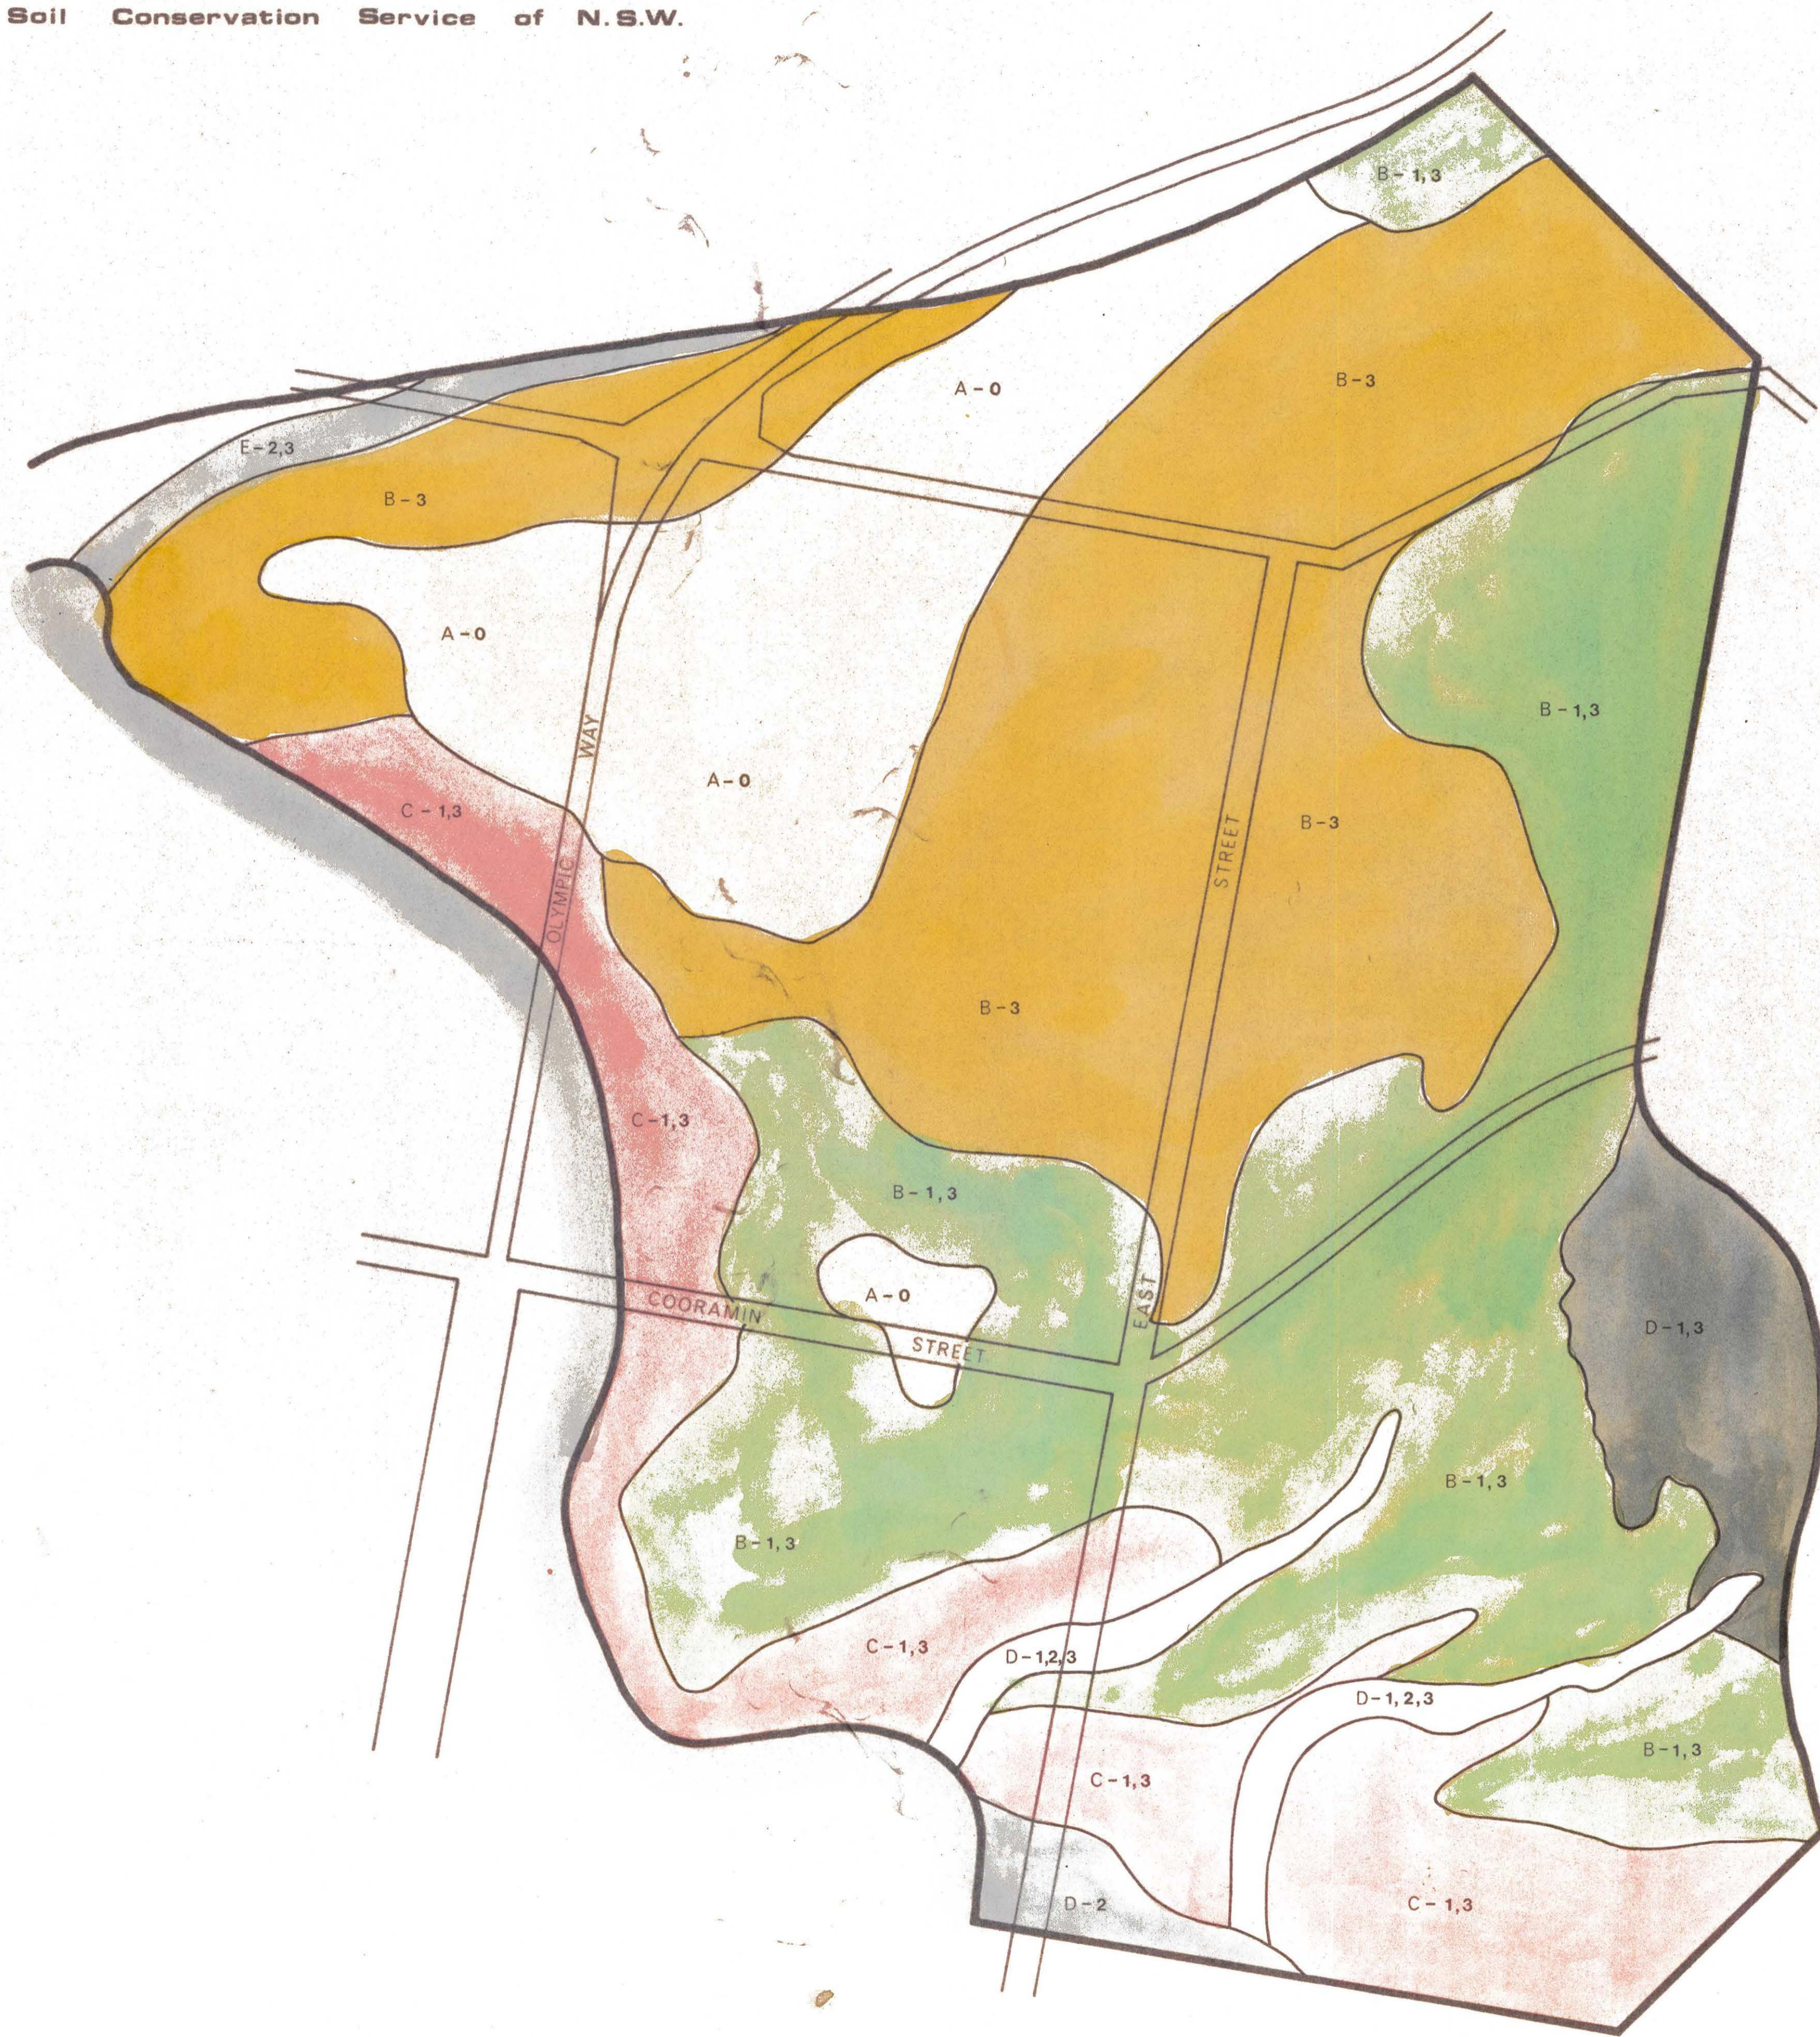
Erosion/Instability Hazard	Major Limitations	Capability	Code
Low	Nil	EBC	A-0
Moderate	Erodible soil	EBC	B-3
Moderate	Slope/erodible soil	Residential	B-1,3
High	Slope/erodible soil	Low density residential	C-1,3
Very high	Slope/erodible soil	Reserve	D-1,3
Very high	Flood plain	Reserve	D-2
Very high	Slope/drainage/erodible soil	Reserve	D-1,2,3
Extreme	Drainage/erodible soil	No development	E-2,3
