Soil Conservation Service of NSW SOILS

SHIRE OF HUME

VILLAGE OF JINDERA and adjoining lands

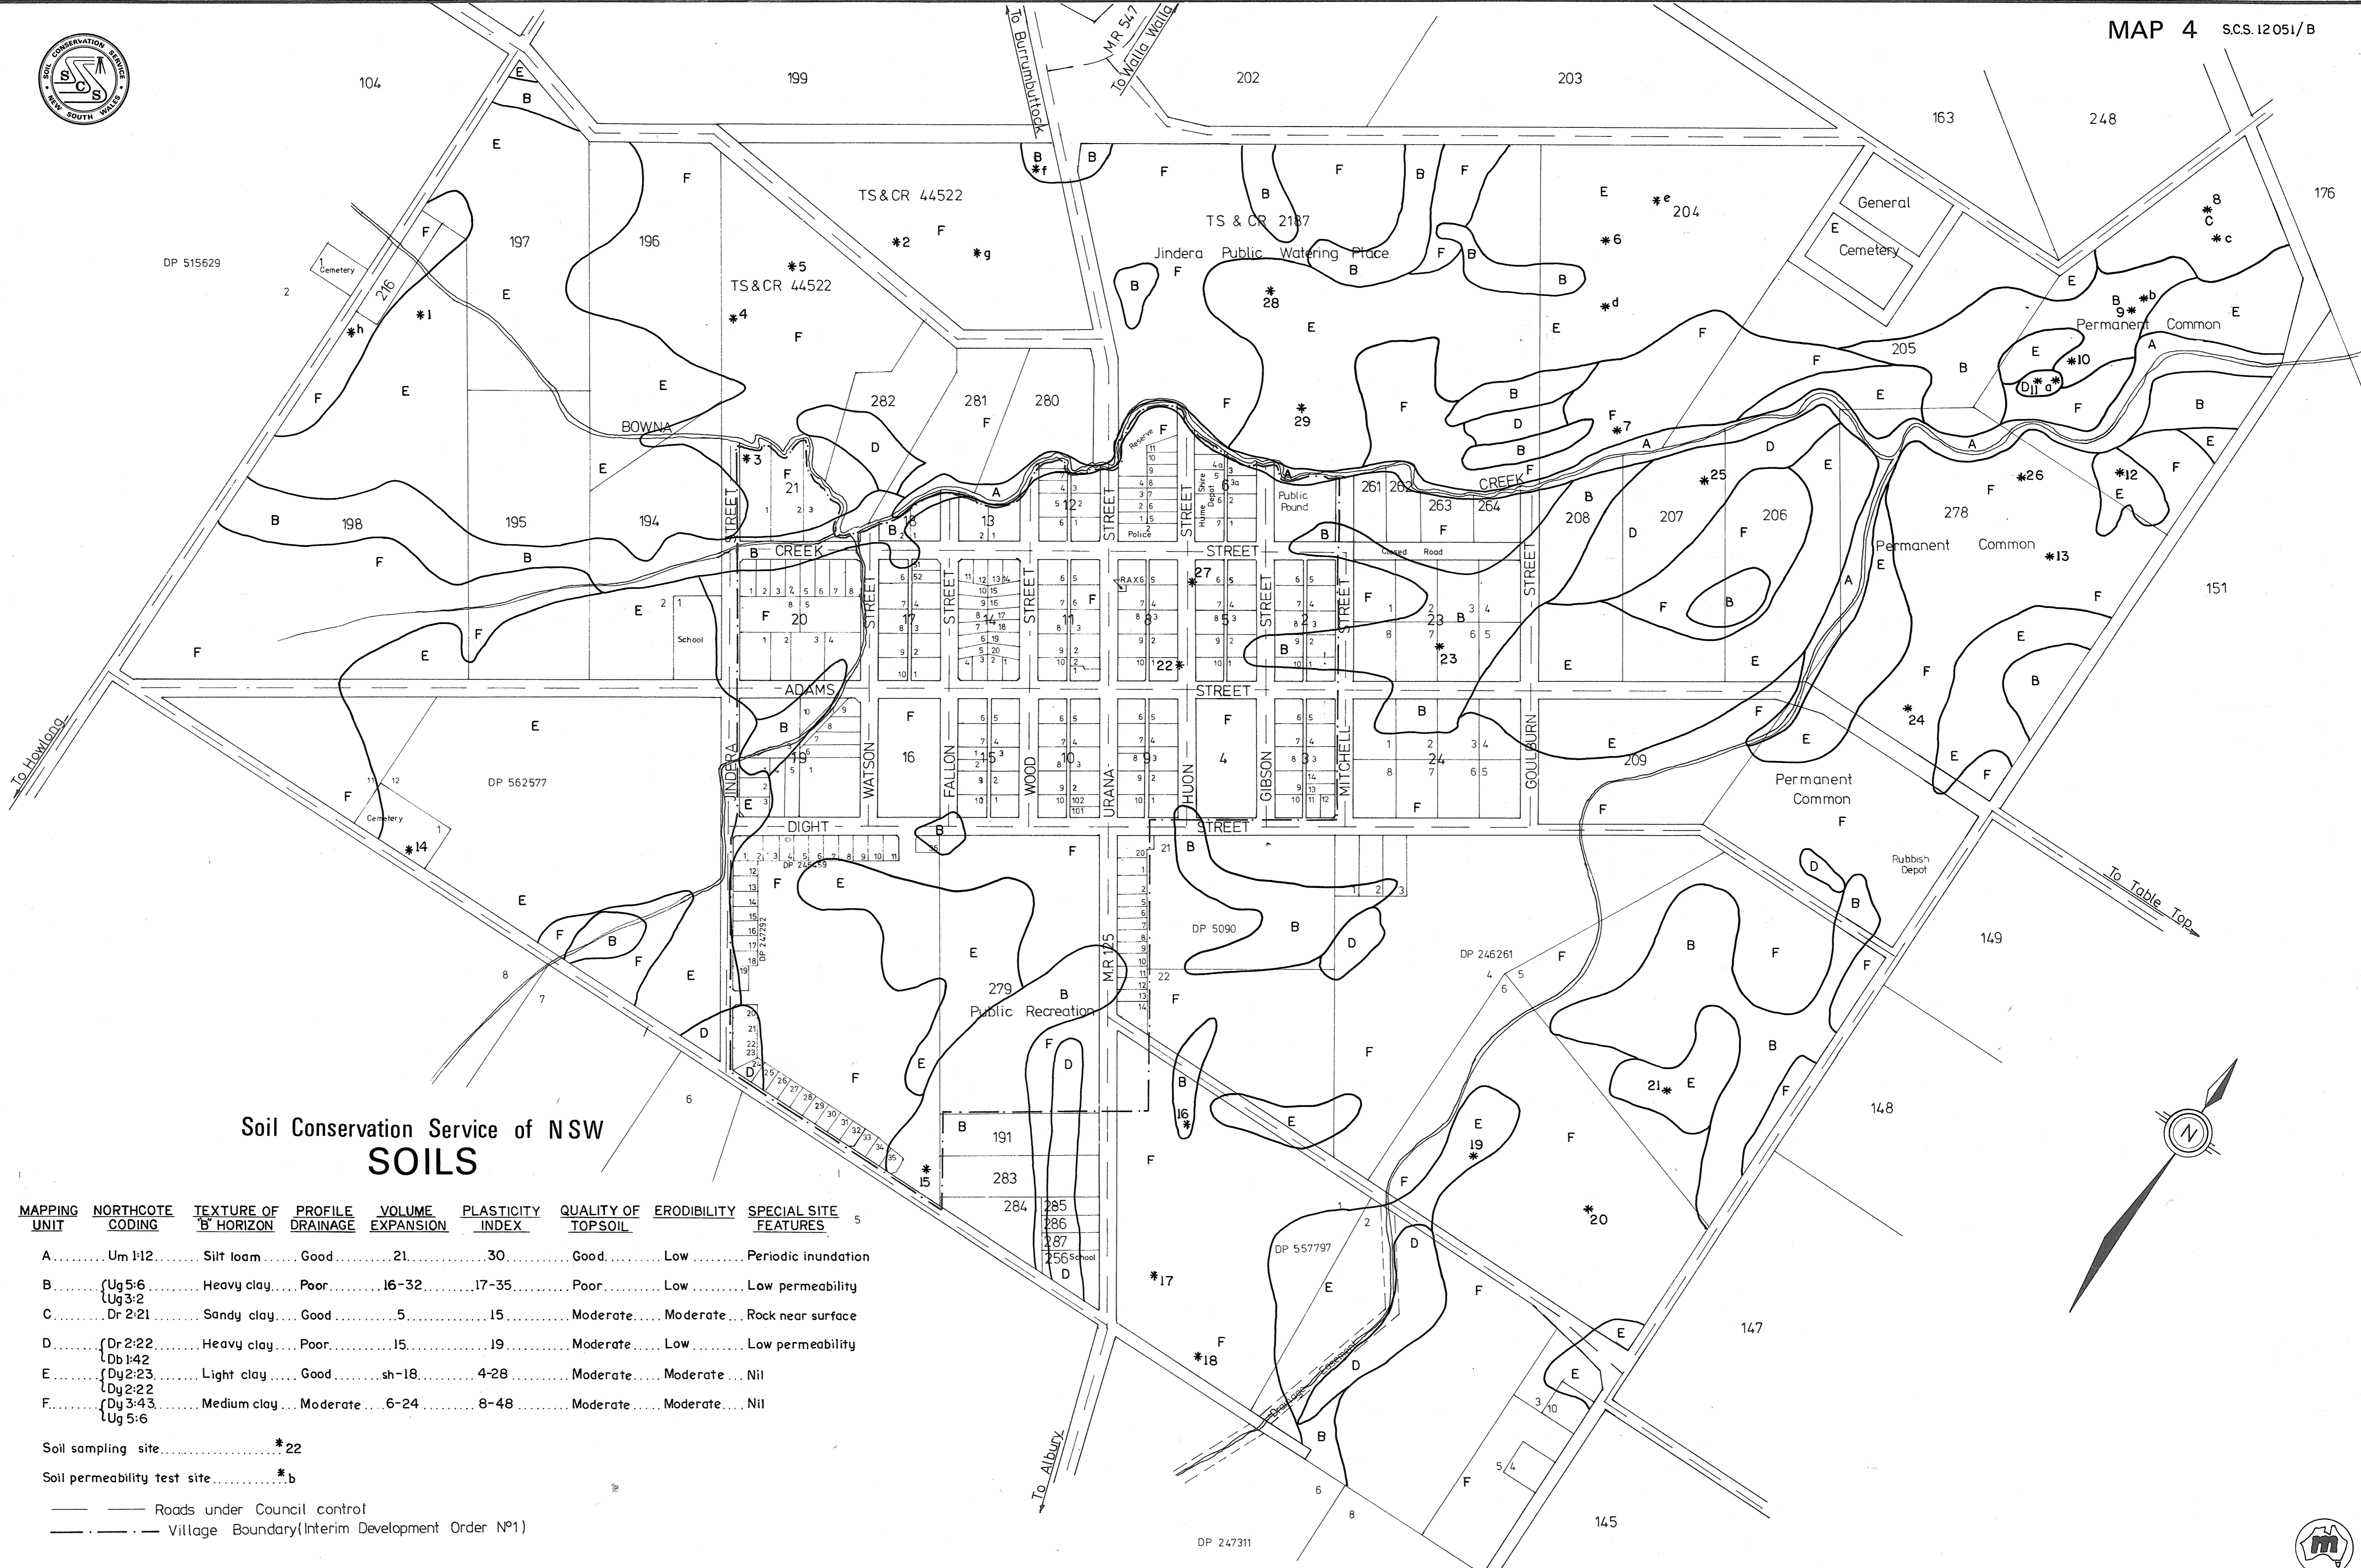
MAPPING UNIT	NORTHCOTE CODING	TEXTURE OF B HORIZON	PROFILE DRAINAGE	VOLUME EXPANSION	PLASTICITY INDEX	QUALITY OF TOPSOIL	ERODIBILITY	SPECIAL SITE FEATURES
A	Um 1:12	Silt loam	Good	21	30	Good	Low	Periodic inundation
B	Ug 5:6 Ug 3:2	Heavy clay	Poor	16-32	17-35	Poor	Low	Low permeability
C	Dr 2:21	Sandy clay	Good	5	15	Moderate	Moderate	Rock near surface
D	Dr 2:22 Db 1:42	Heavy clay	Poor	15	19	Moderate	Low	Low permeability
E	Dy 2:23 Dy 2:22	Light clay	Good	sh-18	4-28	Moderate	Moderate	Nil
F	Dy 3:43 Ug 5:6	Medium clay	Moderate	6-24	8-48	Moderate	Moderate	Nil

Soil sampling site.....*22
 Soil permeability test site.....*b
